AIRPROX REPORT No 2019121

Date: 23 May 2019 Time: 0946Z Position: 5045N 00154W Location: Bournemouth CTR

PART A: SUMMARY OF INFORMATION REPORTED TO UKAB

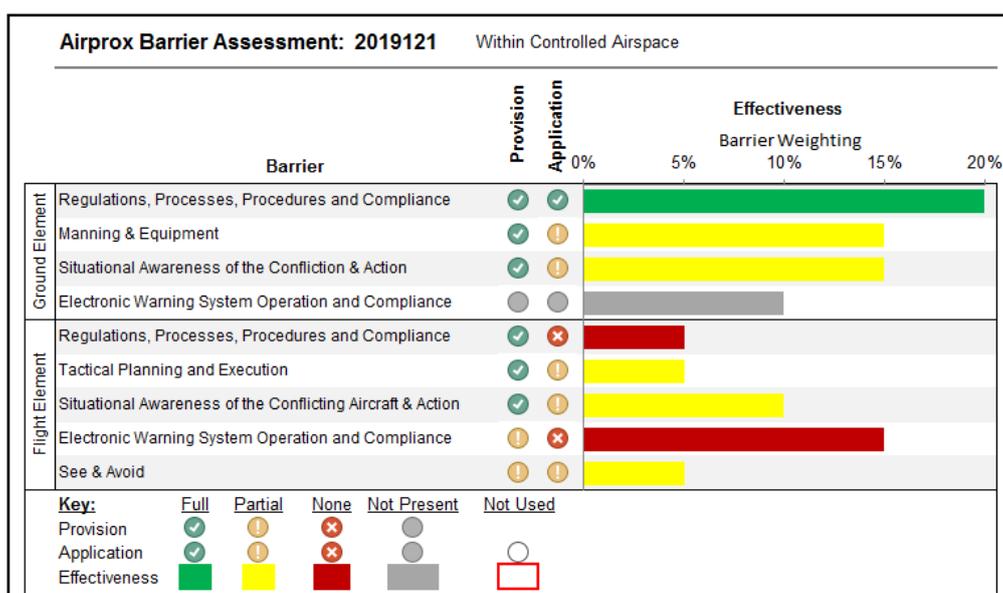
Electronic Warning System Operation and Compliance were assessed as **ineffective** because the PA34's TAS did not alert the pilot to the presence of the PA28 in confliction.

See and Avoid were assessed as **partially effective** because although the PA28 pilot did not see the PA34, the PA34 pilot was alerted later than desirable to the presence of the PA28 by a student pilot in the back-seat and was therefore able to carry out emergency avoiding action.
