AIRPROX REPORT No 2019127

Date: 25 May 2019 Time: 1140Z Position: 5155N 00158W Location: 7.5NM E Gloucester

PART A: SUMMARY OF INFORMATION REPORTED TO UKAB

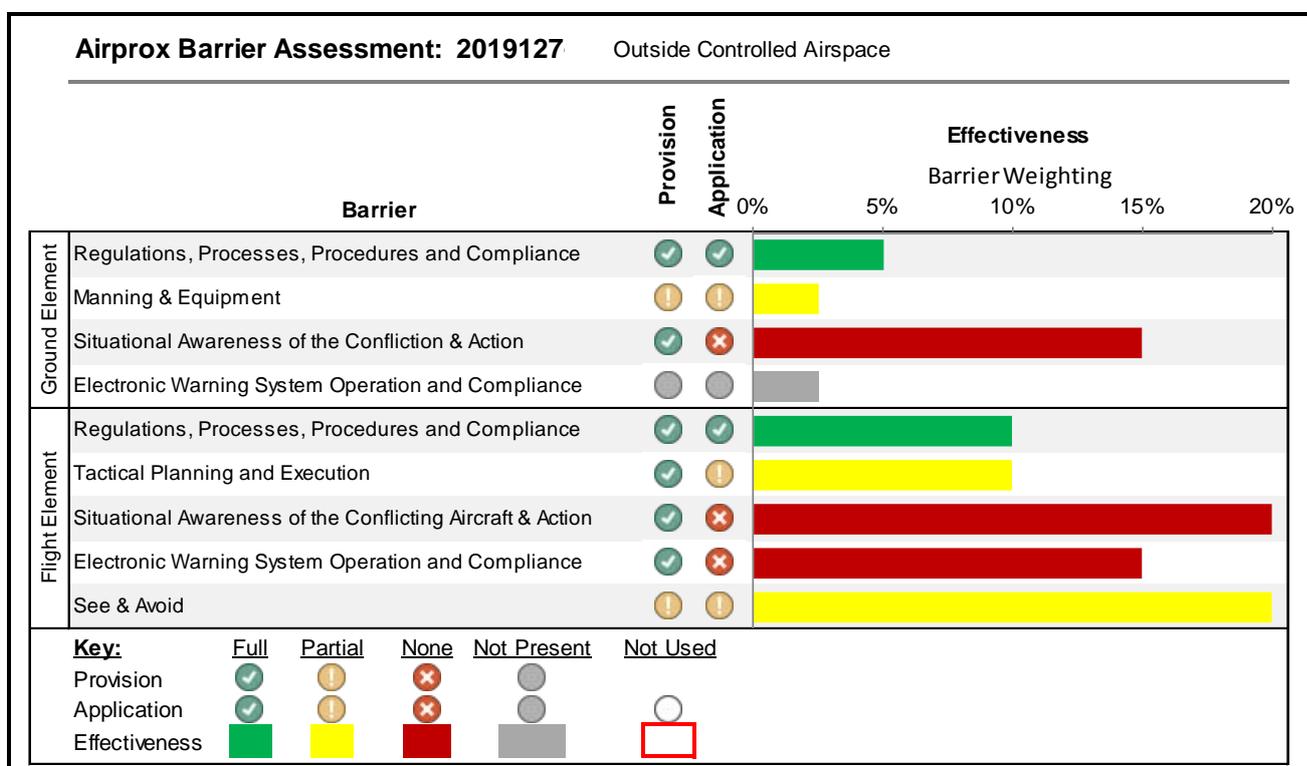
Electronic Warning System Operation and Compliance were assessed as **ineffective** because both pilots received Traffic Information from their TAS but continued closing to a CPA of 0.1NM at the same level.

See and Avoid were assessed as **partially effective** because neither pilot saw the other aircraft until at a late stage, and only one pilot took avoiding action.
