AIRPROX REPORT No 2019131

Date: 01 Jun 2019 Time: 0918Z Position: 5118N 00007E Location: 3nm SE Biggin Hill

PART A: SUMMARY OF INFORMATION REPORTED TO UKAB

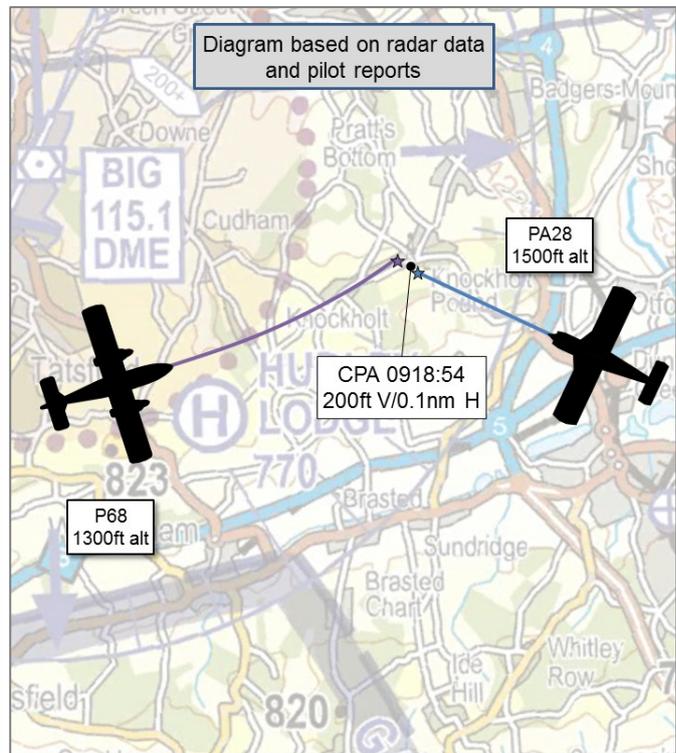
Recorded	Aircraft 1	Aircraft 2
Aircraft	PA28	Partenavia P68
Operator	Civ FW	Civ Comm
Airspace	London FIR	London FIR
Class	G	G
Rules	VFR	VFR
Service	Basic	Basic
Provider	Biggin Hill	Biggin Hill
Altitude/FL	1500ft	1300ft
Transponder	A, C	A, C, S
Reported		
Colours	White, Red	White, Blue
Lighting	Beacon	Nav, Beacon
Conditions	VMC	VMC
Visibility	10km	>10km
Altitude/FL	1000ft	1200ft
Altimeter	QFE (1003hPa)	QNH (1022hPa)
Heading	300°	110°
Speed	98kt	110kt
ACAS/TAS	Not fitted	Not fitted
Separation		
Reported	100ft V/200m H	500ft V/2nm H
Recorded	200ft V/0.1nm H
