AIRPROX REPORT No 2019150

Date: 20 Jun 2019 Time: 1016Z Position: 5247N 00030W Location: 6nm NE of Cottesmore

PART A: SUMMARY OF INFORMATION REPORTED TO UKAB

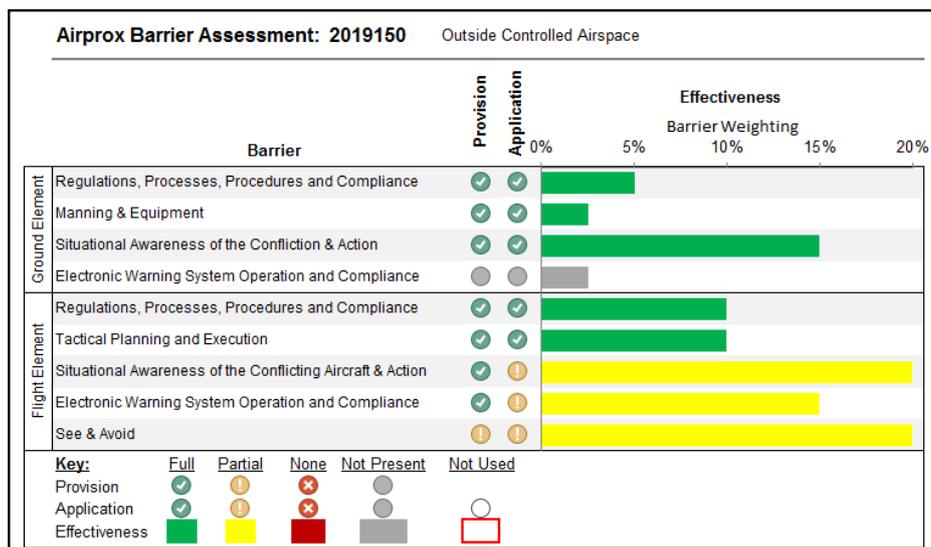
Electronic Warning System Operation and Compliance were assessed as **partially effective** because both pilots had TA indications from their TAS but didn't act soon enough on the information.

See and Avoid were assessed as **partially effective** because the Tutor pilots only saw the Prefect late as they carried out emergency avoiding action. The Prefect pilot only saw the Tutor after it had climbed to avoid the Prefect.
