AIRPROX REPORT No 2019162

Date: 27 Jun 2019 Time: 1247Z Position: 5531N 00434W Location: Prestwick Airport – elev 66ft

PART A: SUMMARY OF INFORMATION REPORTED TO UKAB

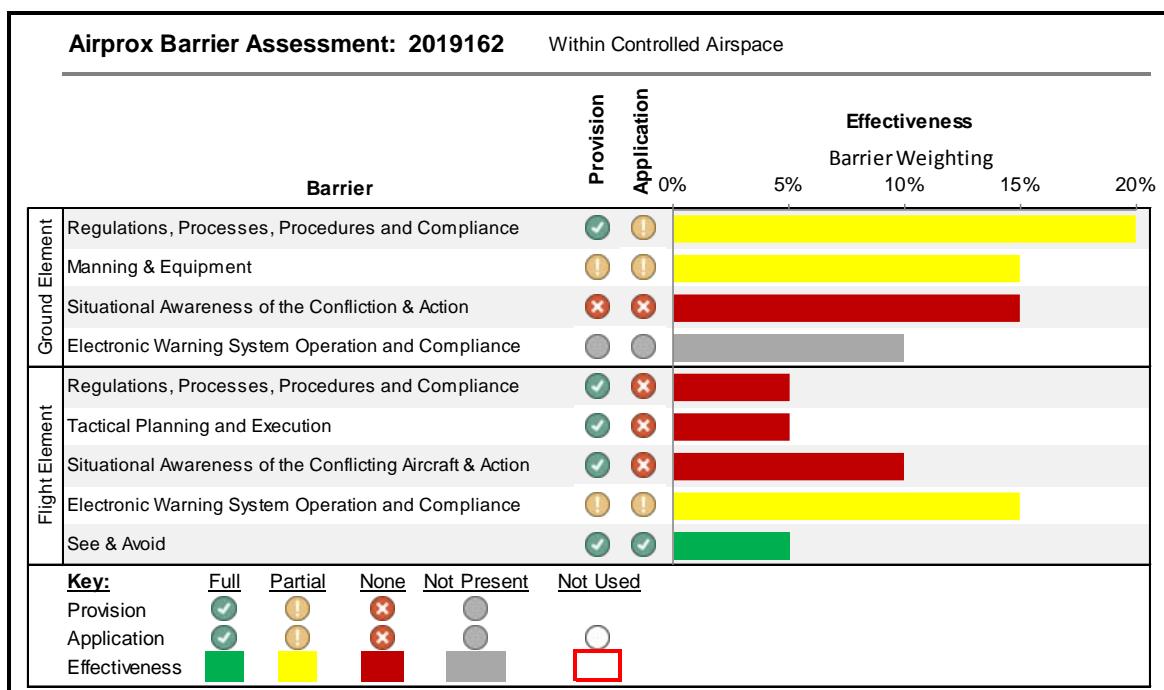
Situational Awareness of the Conflicting Aircraft and Action were assessed as **ineffective** because although the Bulldog pilot was aware of the approaching C560, the available SA was not acted upon, and the C560 pilot was not previously aware of the Bulldog in the visual circuit.

Electronic Warning System Operation and Compliance were assessed as **partially effective** because although the Bulldog was not fitted with a TAS, the C560 had TCAS, which alerted.
