AIRPROX REPORT No 2019163

Date: 22 Jun 2019 Time: 1046Z Position: 5152N 00129W Location: 8nm NW Oxford airport

PART A: SUMMARY OF INFORMATION REPORTED TO UKAB

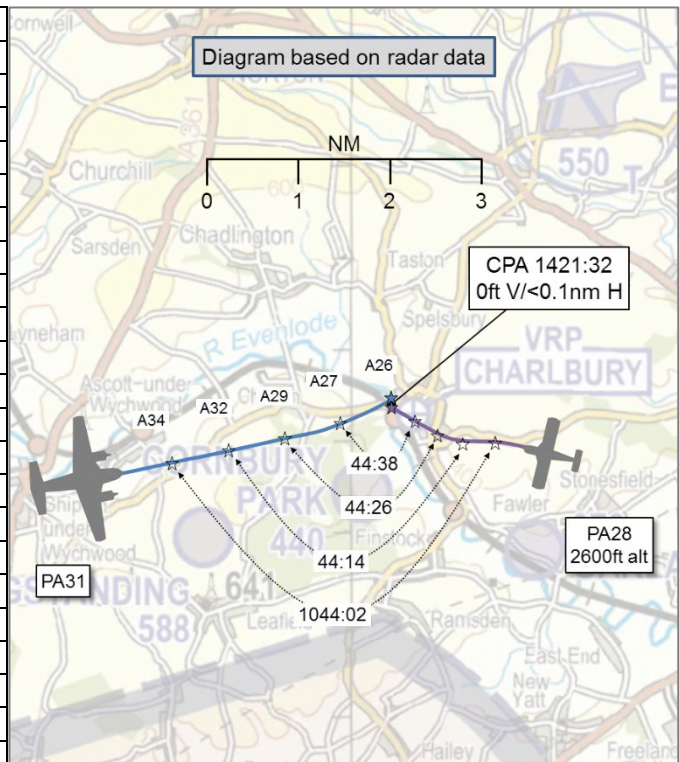
Recorded	Aircraft 1	Aircraft 2
Aircraft	PA31	PA28
Operator	Civ FW	Civ FW
Airspace	London FIR	London FIR
Class	G	G
Rules	VFR	VFR
Service	Traffic	Basic
Provider	Oxford	Oxford
Altitude/FL	2600ft	2600ft
Transponder	A/C/S	A/C/S
Reported		Not reported
Colours	White/blue	
Lighting	Nav, tail beacon	
Conditions	VMC	
Visibility	>10km	
Altitude/FL	2700ft	
Altimeter	QNH	
Heading	090°	
Speed	160kt	
ACAS/TAS	Not fitted	Not fitted
Separation		
Reported	0ft V/600m H	NK
Recorded	0ft V/<0.1nm H

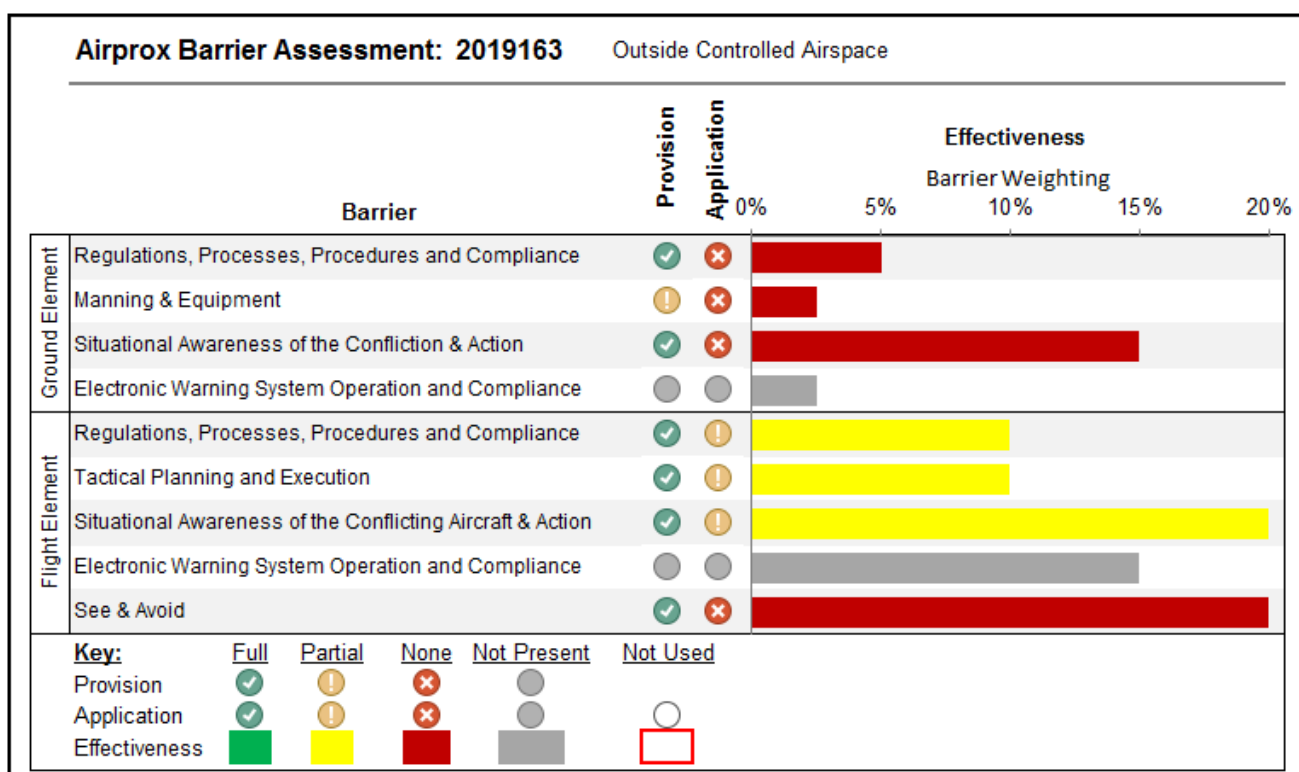
Situational Awareness of the Conflicting Aircraft and Action were assessed as **partially effective** because the PA28 student pilot turned towards the PA31 despite the instructor telling him not to do so.

See and Avoid were assessed as **ineffective** because the PA31 pilot only saw the PA28 late, and the PA28 turned towards the PA31, despite the pilot being visually aware of its position.
