AIRPROX REPORT No 2019199

Date: 18 Jul 2019 Time: 1512Z Position: 5245N 00019W Location: 10nm NE Wittering

PART A: SUMMARY OF INFORMATION REPORTED TO UKAB

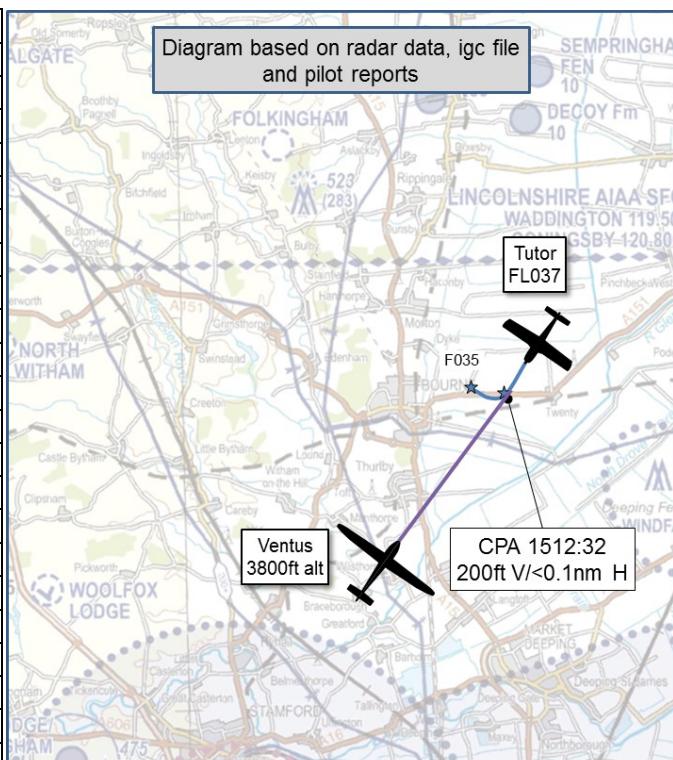
Recorded	Aircraft 1	Aircraft 2
Aircraft	Tutor	Ventus Glider
Operator	HQ Air (Trg)	Civ Gld
Airspace	London FIR	London FIR
Class	G	G
Rules	VFR	VFR
Service	Traffic	None
Provider	Wittering	N/A
Altitude/FL	FL037	3800ft
Transponder	A, C	Off
Reported		
Colours	Blue, White	White
Lighting	Strobe, Nav	None
Conditions	VMC	VMC
Visibility	>10km	Not reported
Altitude/FL	4000ft	
Altimeter	RPS (1003hPa)	
Heading	200°	
Speed	100kt	
ACAS/TAS	FLARM	PowerFLARM
Alert	None	TA
Separation		
Reported	100ft V/0ft H	Not seen
Recorded	200ft V/<0.1nm H
