AIRPROX REPORT No 2019210

Date: 28 Jul 2019 Time: 1001Z Position: 5153N 00205W Location: Gloucestershire Airport

PART A: SUMMARY OF INFORMATION REPORTED TO UKAB

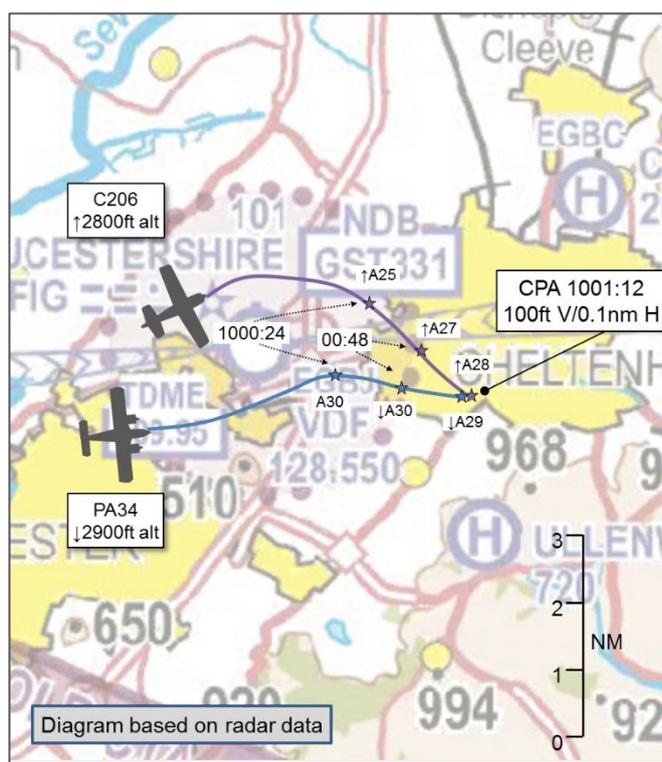
Recorded	Aircraft 1	Aircraft 2
Aircraft	PA34	C206
Operator	Civ FW	Civ FW
Airspace	London FIR	London FIR
Class	G	G
Rules	IFR	VFR
Service	Procedural	Basic
Provider	Gloster App	Gloster
Altitude/FL	FL031	FL030
Transponder	A, C, S	A, C, S
Reported		
Colours	White, Blue	White, Red
Lighting	Strobes, Nav	Beacon, Strobes
Conditions	VMC	VMC
Visibility	>10km	10km
Altitude/FL	2800ft	2000-3000ft
Altimeter	QNH (1006hPa)	QNH (1009hPa)
Heading	090°	125°
Speed	120kt	110kt
ACAS/TAS	TAS	TAS
Alert	TA	None
Separation		
Reported	150ft V/0m H	Not Seen
Recorded	100ft V/0.1nm H
