AIRPROX REPORT No 2019216

Date: 25 May 2019 Time: 1147Z Position: 5136N 00052W Location: IVO Wycombe

PART A: SUMMARY OF INFORMATION REPORTED TO UKAB

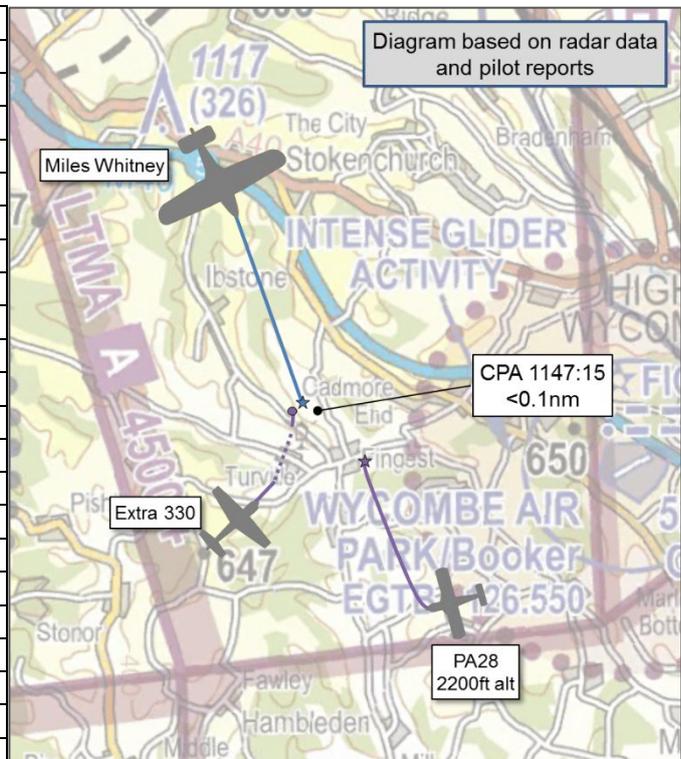
THE MILES WHITNEY PILOT reports that the aircraft had just returned from maintenance having had a new 8.33KHz radio fitted. However, the radio was not properly set up, the engineer had taken the manual away, and there was a loud static noise which could not be suppressed by the squelch button. The outward flight was difficult, with various ATC agencies not able to be heard. He needed the squawk relaying by another aircraft at one point and so on the return flight he did not bother with Farnborough, preferring to keep a good look-out instead. He noted that, in addition to the radio problem, the aircraft was heavy with a centre of gravity that was too rearward, making control in gusty conditions tricky and increasing the workload. On returning he pointed out an old PA28, possibly a Piper 140 to his passenger, which was only about 100ft to the left, when suddenly a metallic-blue Extra passed directly overhead, in the opposite direction, just above and at high speed.
