AIRPROX REPORT No 2019245

Date: 22 Aug 2019 Time: 1205Z Position: 5201N 00003W Location: Royston

PART A: SUMMARY OF INFORMATION REPORTED TO UKAB

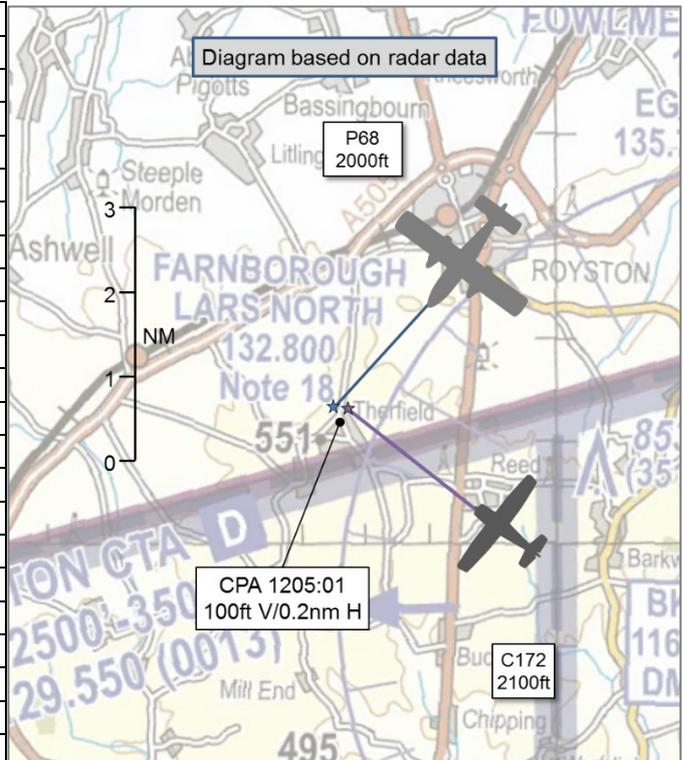
Recorded	Aircraft 1	Aircraft 2
Aircraft	P68	C172
Operator	Civ Comm	Civ FW
Airspace	London FIR	London FIR
Class	G	G
Rules	VFR	VFR
Service	Basic	Basic
Provider	Cambridge	Essex ¹
Altitude/FL	2000ft	2100ft
Transponder	A, C, S	A, C
Reported		
Colours	White, Blue	White, Gold
Lighting	Nav, Landing	Strobes
Conditions	VMC	VMC
Visibility	>10km	10km
Altitude/FL	1800ft	2000ft
Altimeter	QNH (1023hPa)	QNH
Heading	220°	285°
Speed	100kt	110kt
ACAS/TAS	Not fitted	Not fitted
Separation		
Reported	0ft V/30-50m H	Not Seen
Recorded	100ft V/0.2nm H
