**AIRPROX REPORT No 2019246**

Date: 22 Aug 2019 Time: 1559Z Position: 5212N 00010E Location: Cambridge Airport

**PART A: SUMMARY OF INFORMATION REPORTED TO UKAB**

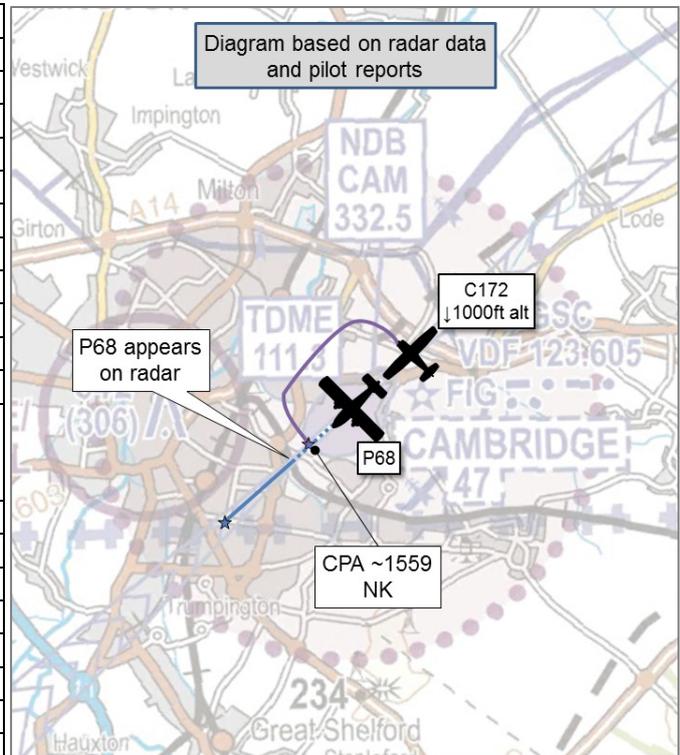
**THE P68 PILOT** reports that he took off behind an Extra and his attention was on the Extra to maintain a safe distance from them. Also, due to Cambridge being a controlled airport, he was expecting ATC to inform him of any other traffic and maintain a safe distance from them. At about 200ft, he saw an aircraft in his 1-2 o'clock on the deadside joining crosswind at very low level. He pitched the nose down into straight-and-level flight, the other aircraft overflew him by less than 200ft. Without him spotting the other aircraft or taking action their paths would have led to a mid-air collision. ATC did not warn him about the traffic. Once clear of the conflict he resumed his climb to 2000ft and continued straight out. Only when the aircraft had cleared him and had started to join downwind did the Tower controller query what the aircraft was doing; it became clear that it was a student who had not understood their clearance. So as not to unnerve the student, he decided to report the incident after being handed over to Approach.

**THE C172 PILOT** reports that he was returning from his cross-country qualifying flight and knew instantly that the airport was extremely busy. In fact, he remembers that he had to wait quite a long time to actually get his call in for joining the airport for an overhead join for RW23. He came overhead and descended deadside to 1000ft. He was told to report ready when crosswind but, at this point, he had already started to turn onto crosswind. He then made a call saying something along the lines of "[C/S] at crosswind" and the controller said something like "but I told you to report ready". After this the controller then told him to carry on as he was. During this time, he did not receive any instructions to, for example, tell him to climb, orbit or manoeuvre in any way. He then reported downwind, then final and landed safely. The flying club was informed of the Airprox by RAC on 9th September 2019, so this report is from what he can remember.

**THE CAMBRIDGE AERODROME CONTROLLER** reports that he had been in position for 1hr, working heavy traffic levels. The C172 student pilot called for an overhead join, which was approved. The P68 pilot was cleared for take-off, RW23. The pilot of the C172 reported descending deadside, and was instructed to report ready to turn crosswind, with Traffic Information on the departing P68. A few moments later the C172 was seen turning onto the downwind leg having failed to make the crosswind call. The P68 was transferred to Cambridge Radar, the pilot reported an Airprox at approximately 1604hrs with Radar, passing within 300ft of the C172 on departure while with Cambridge Tower.

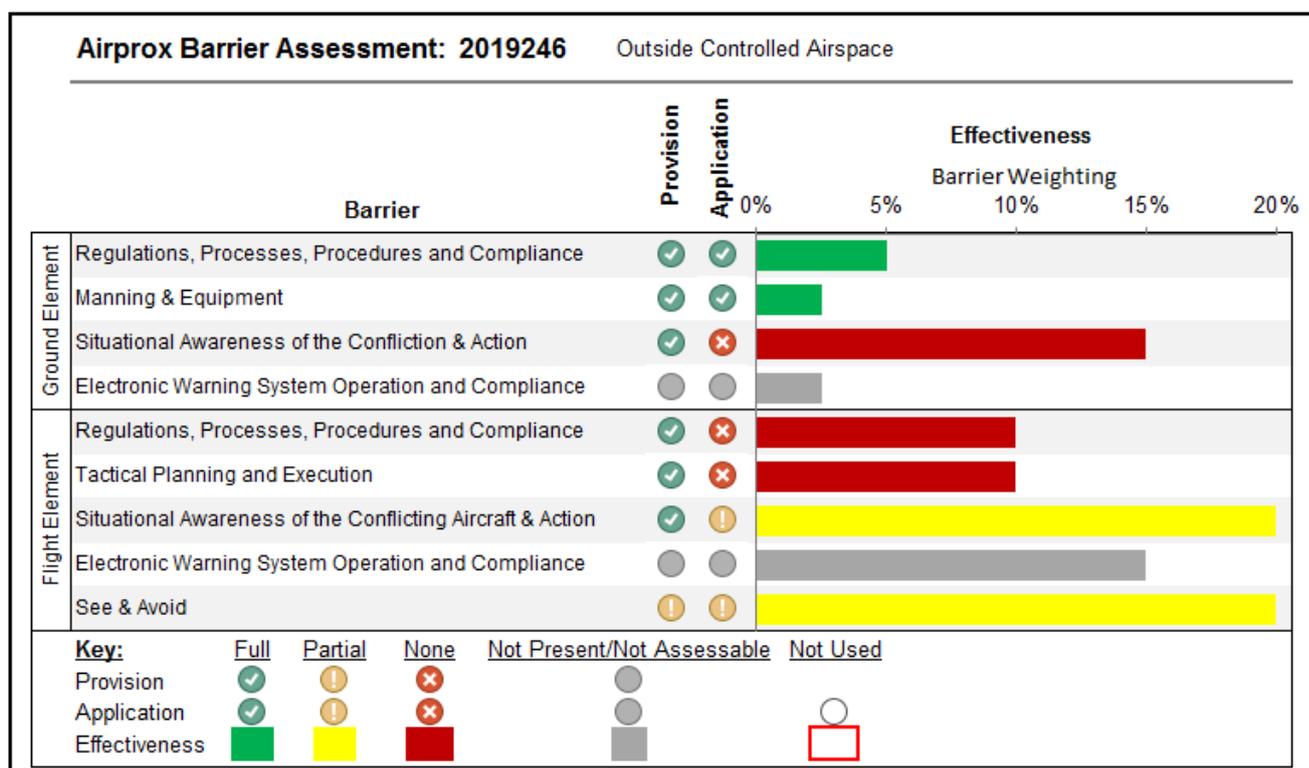
**Situational Awareness of the Conflicting Aircraft and Action** were assessed as **partially effective** because the C172 pilot did not assimilate or act on the available Traffic Information on the P68. The P68 pilot did not have accurate information on the position of the C172.

**See and Avoid** were assessed as **partially effective** because the C172 pilot did not see the P68. The P68 pilot saw the C172 late and took avoiding action.
