AIRPROX REPORT No 2019284

Date: 21 Sep 2019 Time: 0835Z Position: 5109N 00135W Location: Middle Wallop

PART A: SUMMARY OF INFORMATION REPORTED TO UKAB

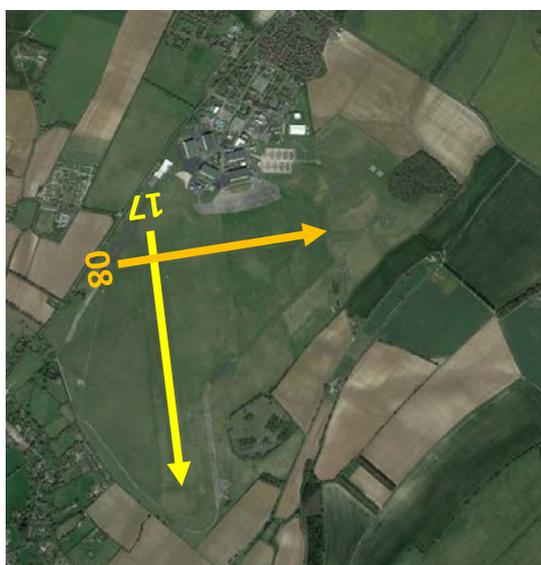
Figure 1

An Airprox was reported by the Middle Wallop Tower Controller between a Tecnam Sierra and a Chipmunk while both were joining the circuit to land at Middle Wallop. Area radar coverage in this area is poor, and does not show CPA; however, it was able to illustrate the initial positioning of the aircraft which led to their coming into proximity. Although the Airprox was filed between the Tecnam and the Chipmunk, a third aircraft, a PA28, was joining to land at the same time and its inclusion is pertinent to the initial stages of this event, though not part of the Airprox itself. Figure 1, taken from Google Earth, shows the airfield layout at Middle Wallop.

It is recommended that, if airfield layout maps are placed within a briefing pack, they should contain a clear statement of 'Do not use for navigational purposes' unless they are specifically sourced and approved charts. It is also recommended that, for a fly-in event such as this, company callsigns should not be used. All arrivals had been booked-in with aircraft registrations and this caused a significant increase in workload for the ATCO and, possibly, the pilot might not have been focussing on the callsign if they were expecting the company callsign to be used. It is recommended that [the operating authority] be debriefed on this and consider this for future events.
