AIRPROX REPORT No 2019285

Date: 19 Sep 2019 Time: 1603Z Position: 5207N 00002E Location: 7nm SW Cambridge

PART A: SUMMARY OF INFORMATION REPORTED TO UKAB

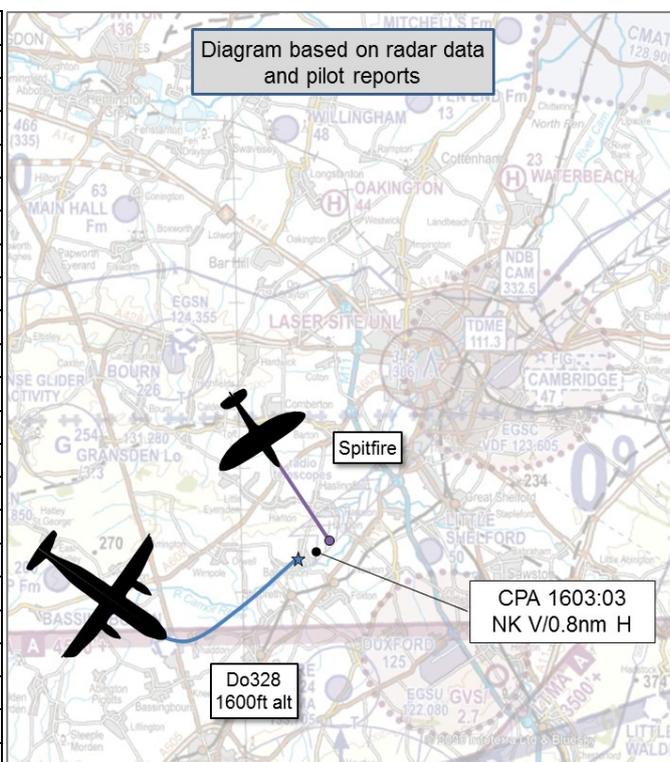
THE CAMBRIDGE APPROACH OJTI CONTROLLER reports that at 15:59 the Do328 called Cambridge outbound for the NDB approach RW05. At this time, the screen controller saw a Spitfire operating on the outbound track without secondary radar displaying, but then it departed that area to the west. As the Do328 established on the Final Approach Track (FAT) the screen controller saw the Spitfire track towards Duxford from the west. He took control from the trainee and started to pass traffic information to the Do328 pilot on the Spitfire. He thinks he passed Traffic Information 3 times on the Spitfire to the Do328 pilot. He observed the Spitfire to the NW of the FAT by about 2nm, height estimated to be about 3000ft. He saw the Spitfire from the VCR and additional information from the ATM, the Spitfire then entered a high-speed dive and crossed ahead of the Do328 at about 0.5nm at a very similar level. The OJTI believes that the speed of the Spitfire was not accurately represented on the radar display because of the vertical vector component.
