## AIRPROX REPORT No 2019290

Date: 21 Sep 2019 Time: 1217Z Position: 5150N 00058W Location: 1.5nm south of Westcott NDB

### PART A: SUMMARY OF INFORMATION REPORTED TO UKAB

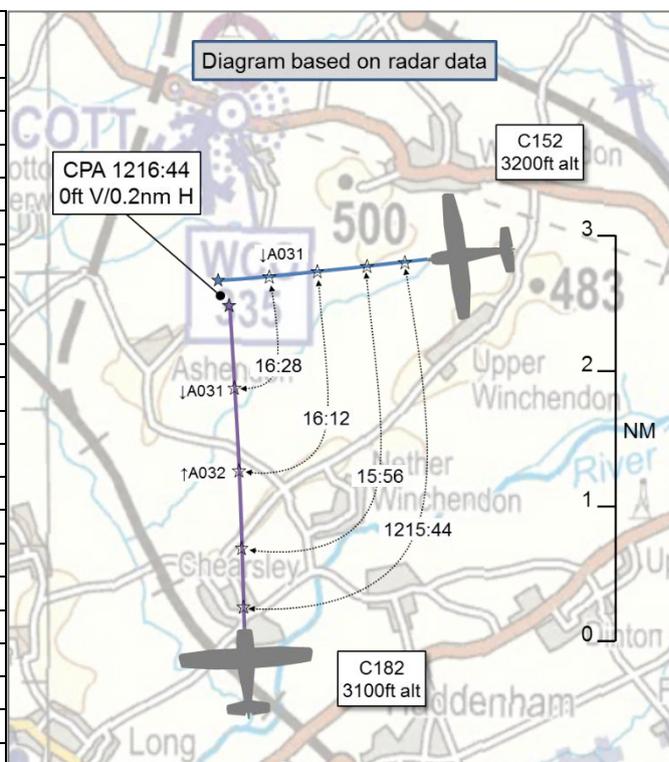
**THE C152 PILOT** reports that, when north of Aylesbury, he reported leaving the zone of his departure airfield and changed to Oxford Radar. He changed frequency and listened-out while climbing to 3100ft and aligning himself with his first navigation point (a railway/road crossing point) north-west of Aylesbury. Overhead the navigation point, he then set his heading for the Oxford Airport overhead, commenced timing the leg and listened-out on the frequency before speaking to Oxford Radar. He is very much aware of how busy the airspace can get around Waddesdon, checked for traffic to the north and south of track, and checked Skydemon to ensure that he was not heading towards the Weston-on-the-Green parachute zone. He also asked his passenger to report, and point out, any aircraft. On calling Oxford Radar for a Basic Service, he had his pen in hand and was facing forwards so he could note and write down the squawk code and QNH quickly. The immediate response from Oxford Radar was words to the effect of '[C152 C/S], Oxford Radar, you have an aircraft reporting your altitude headed towards you immediately to your left'. He turned and looked over his left shoulder (approximately his 8 o'clock) and saw the described aircraft fly very close behind him. He turned to his right as it passed behind and saw it depart to the north (approximately his 3 o'clock). It showed no indication of having manoeuvred in heading or altitude to avoid his aircraft. He did not see any persons on board. He did not have any time to manoeuvre to take avoiding action and he estimated the aircraft to have been within 50m of his position when he initially saw it, and passed perhaps two secs later. He replied to Oxford Radar with words to the effect of 'that was close - thank you', and proceeded to receive his squawk code and QNH details.

The pilot assessed the risk of collision as 'High'.
