AIRPROX REPORT No 2019291

Date: 02 Oct 2019 Time: 1414Z Position: 5053N 00037W Location: 6nm NW of Littlehampton

PART A: SUMMARY OF INFORMATION REPORTED TO UKAB

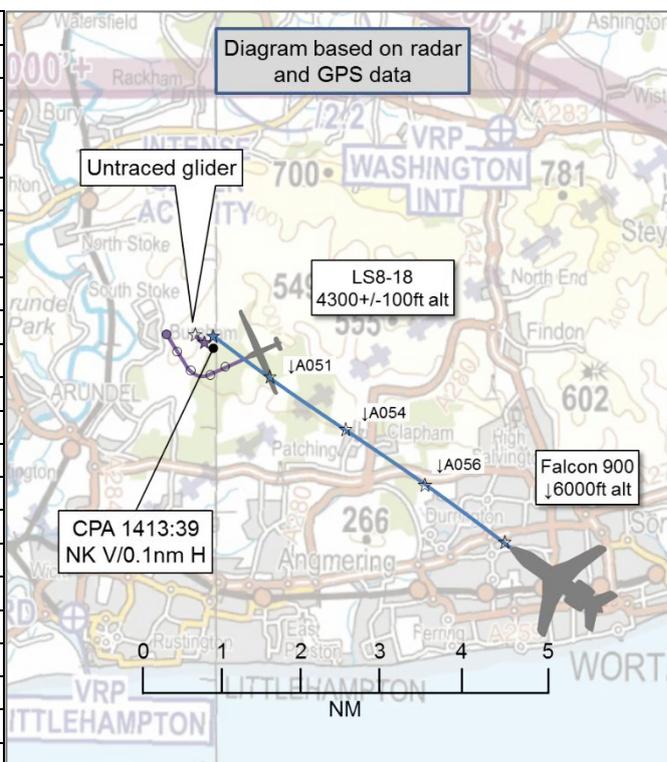
THE FALCON 900EX PILOT reports that he was in the descent to his destination and had been cleared to descend to 5000ft by the London controller. Shortly after levelling at his cleared altitude, he spotted a white glider, possibly with a high tail, 800-1000m away. He did not take any avoiding action but reported the Airprox to ATC.
