AIRPROX REPORT No 2019294

Date: 09 Oct 2019 Time: 1244Z Position: 5141N 00220W Location: 1.3nm west Nympsfield

PART A: SUMMARY OF INFORMATION REPORTED TO UKAB

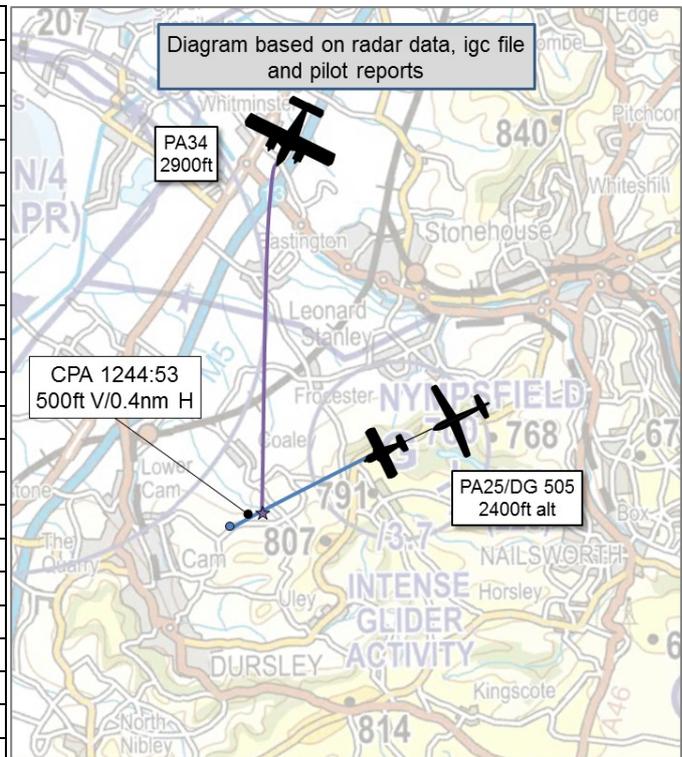
THE DG 505 PILOT reports that he was instructing another pilot, being aerotowed about 2nm to the SW of Nympsfield airfield at about 2000ft, traveling SW climbing at 450ft/min, when a light-twin, he thought a Seneca, flew over the top of him, about 200-300ft above, traveling in a southerly direction. The aircraft appeared from their 4 o'clock. The twin flew straight-and-level and he thinks the pilot did not see them. They did not see it until it had just passed them. It was flying quite fast. The towing aircraft was an orange coloured Pawnee (PA25). Visibility was very good. There was no immediate danger of collision but, in his opinion, the twin flew unnecessarily close to an active gliding site without keeping an adequate lookout. The glider and PA25 both had FLARM that was working. He doesn't think the twin aircraft had FLARM.

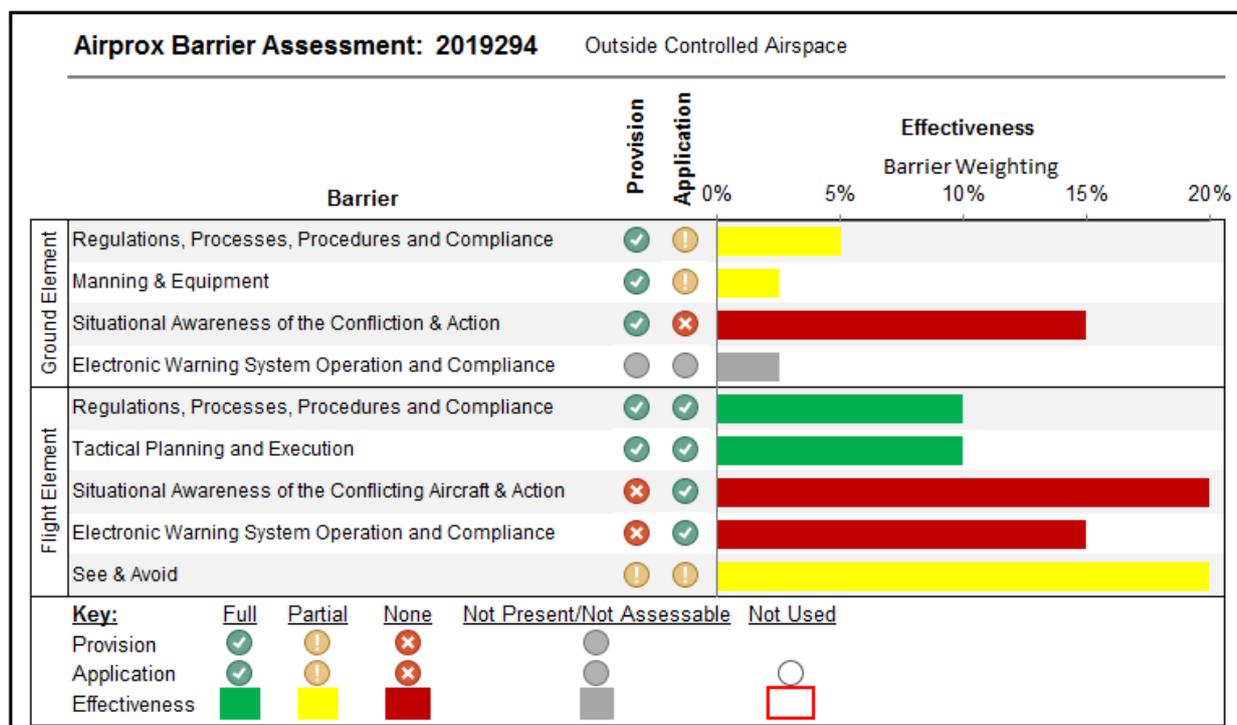
Electronic Warning System Operation and Compliance were assessed as **ineffective** because the FLARM system is incompatible with non-FLARM equipped transponding aircraft.

See and Avoid were assessed as **partially effective** because the DG 505 pilot saw the PA34 late and the PA34 pilot did not see the glider/tug combo.

Recommendation: The BGA reiterate guidance to gliding clubs regarding the significant mitigation to mid-air collision afforded by fitment of SSR transponders to tug aircraft.
