AIRPROX REPORT No 2019296

Date: 03 Oct 2019 Time: 1027Z Position: 5802N 00247W Location: 27nm NE of Lossiemouth

PART A: SUMMARY OF INFORMATION REPORTED TO UKAB

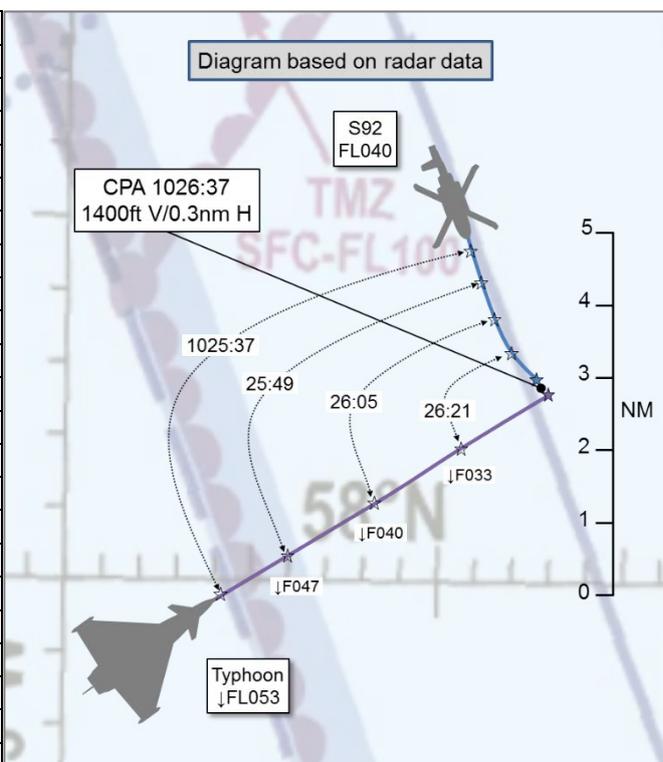
THE S92 PILOT reports that he was routing between Wick and Aberdeen at 4000ft and, while passing abeam EG D809, he observed an aircraft on TCAS approximately 15nm west-abeam his position and 2000ft above. The aircraft started to descend and continued towards his position and then passed below abeam, or slightly behind, his aircraft at an approximate distance of 3nm as he received a TA warning. The pilot took avoiding action by turning left onto a heading of 133°.

THE TYPHOON PILOT reports that he was tasked with supporting [an aircraft carrier] in the Moray Firth. After a short transit speaking to Swanwick Mil, they descended to low-level over the sea to remain VMC whilst checking-in with the carrier's approach controller.² Following a climb away from the carrier in close formation to simulate a departure from the ship, albeit starting at 1,500ft, he became aware of a Link 16 surveillance track in the vicinity of the operating airspace. Shortly after this, a courtesy radio call was made by the carrier. By this point they were in the descent back to low-level and still in close formation. He then visually acquired the contact, which he could now see to be a helicopter, at an estimated range of 1.5nm in his 10 o'clock and an estimated 1000ft above his aircraft. Until the courtesy call, he had not appreciated that the carrier was unable to provide information on conflicting traffic. A better plan would have been to have kept a listening watch with Lossiemouth Approach and to have accepted that the Service would have been intermittent given the nature and position of the tasking.
