AIRPROX REPORT No 2019312

Date: 09 Nov 2019 Time: 1228Z Position: 5316N 00057W Location: Retford/Gamston ATZ

PART A: SUMMARY OF INFORMATION REPORTED TO UKAB

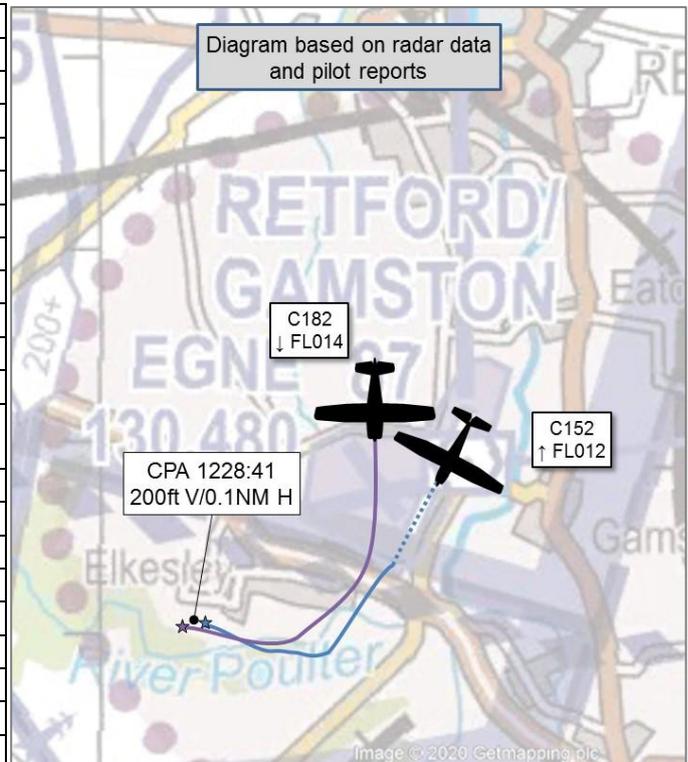
Recorded	Aircraft 1	Aircraft 2
Aircraft	C152	C182
Operator	Civ FW	Civ FW
Airspace	Gamston ATZ	Gamston ATZ
Class	G	G
Rules	VFR	VFR
Service	AGCS	AGCS
Provider	Gamston	Gamston
Altitude/FL	FL012	FL014
Transponder	A, C	A, C, S
Reported		
Colours	White	White, Red, Blue
Lighting	Nav	Strobe, Landing, Beacon
Conditions	VMC	VMC
Visibility	>10km	7km
Altitude/FL	700ft	1100ft
Altimeter	QFE (1008hPa)	QNH
Heading	270°	300°
Speed	70kt	105kt
ACAS/TAS	Not fitted	TAS
Alert	N/A	None
Separation		
Reported	50ft V/0NM H	Not seen
Recorded	200ft V/0.1NM H

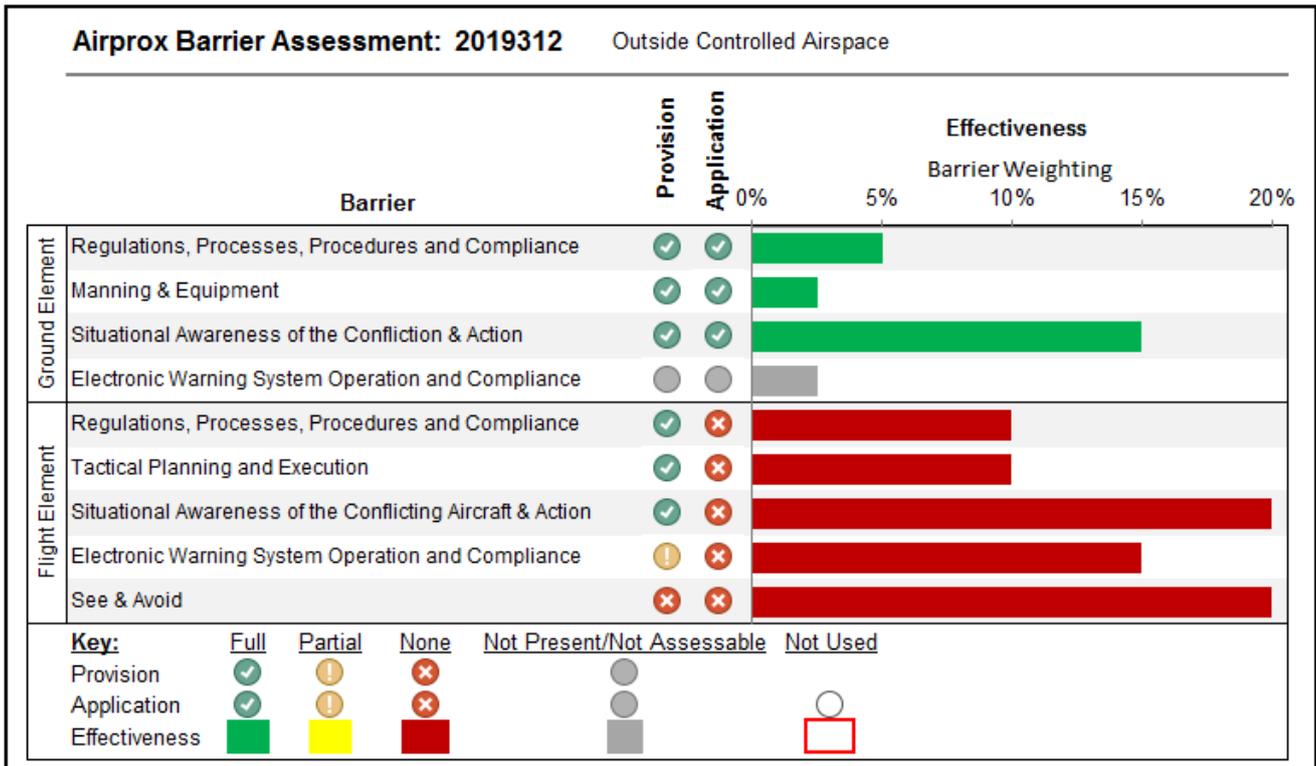
See and Avoid were assessed as **ineffective** because neither pilot saw the other aircraft in time to increase separation.
