AIRPROX REPORT No 2019329

Date: 05 Dec 2019 Time: 1428Z Position: 5757N 00103W Location: 50NM NE Aberdeen

PART A: SUMMARY OF INFORMATION REPORTED TO UKAB

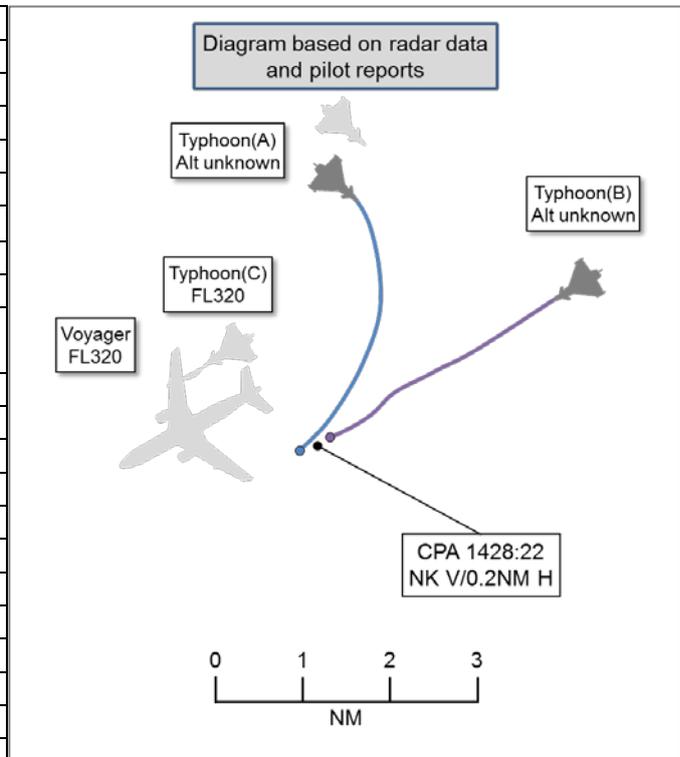
THE TYPHOON(A) PILOT reports that, upon joining the tanker, his formation joined in front of another aircraft that was joining the tanker at the same time, crossing its level in the process. His post-mission debriefing and analysis confirmed that his formation appeared in the windscreen of Typhoon(B), co-level, and at a range of approximately 1800ft. The Typhoon(B) pilot had radar situational awareness (SA) on them joining at much greater range, but switched his attention to the visual join on the tanker. The Typhoon(B) pilot's SA was next updated when Typhoon(A)'s formation appeared visually in front of him in his windscreen. The Typhoon(A) pilot's situational awareness (from radar, MIDS² and ATC) was that the tanker had '2 chicks in tow'. They were cleared to join at FL310 by Swanwick(Mil) and then changed to the boom frequency. They were surprised to see only one aircraft [Typhoon(C)] behind the tanker when they acquired it visually during the join. On check-in on the boom frequency, it immediately became apparent that they had cut-in ahead of another aircraft that was in the process of joining the tanker. The Typhoon(B) pilot reported (on the boom frequency) that he was visual with them. They were not visual with Typhoon(B) at any point because they were 'belly-up' during the join and he was now in their 6 o'clock. The tanker then re-ordered the formation for them to join ahead of Typhoon(B). The Typhoon(A) pilot's main concern was that they were cleared to a level that was not vacated and it would seem that SA had broken down between all aircraft involved and ATC. It was by luck, rather than judgement, that the 2 aircraft didn't conflict, co-altitude, with Typhoon(B) at a much closer range. In addition to being given a conflicting joining level, there were several aggravating factors:

THE TYPHOON(B) PILOT reports that he was cleared by Swanwick(Mil) to FL290 prior to switching to the tanker's boom frequency. At this point, Typhoon(C) was ahead of him and cleared to FL300. The Typhoon(A) formation then came up on the frequency and were cleared to FL280. On contacting the tanker, he was cleared to remain at FL290 and then, once cleared, to expect to climb to FL310. He became visual with the tanker at 3 miles trail and was cleared by the tanker to join visually. The Typhoon(B) pilot then called that he was leaving FL290 for FL310 while he continued to close on the tanker, which was at FL320. At 2 miles trail, the Typhoon(A) formation came up on the tanker frequency requesting to join at FL310. At this point, he was now established at FL310 and, from previous radar SA on the Typhoon(A) formation, knew they were joining from the head sector to his right. He looked right and saw the pair of Typhoons, co-altitude, approximately half-way way around their final turn onto the tanker. He selected his throttles to idle and carried out a small weave in order to build range. Throughout this turn, the tanker crew was trying to establish if the Typhoon(A) formation's pilots were visual with Typhoon(B). The Typhoon(A) pilot called visual with the tanker and one chick in trail (Typhoon(C)). The Typhoon(B) pilot then called visual with the Typhoon(A) formation and that he would remain clear. At this point, the tanker crew cleared the Typhoon(A) formation to continue their join and cleared the Typhoon(B) pilot to descend to FL300. The range between the Typhoon(A) formation and his aircraft was assessed to be around 1800ft at its closest, as the Typhoon(A) formation rolled out in his 12 o'clock.
