AIRPROX REPORT No 2019335

Date: 30 Dec 2019 Time: 1552Z Position: 5139N 00037W Location: 1NM SW Amersham

PART A: SUMMARY OF INFORMATION REPORTED TO UKAB

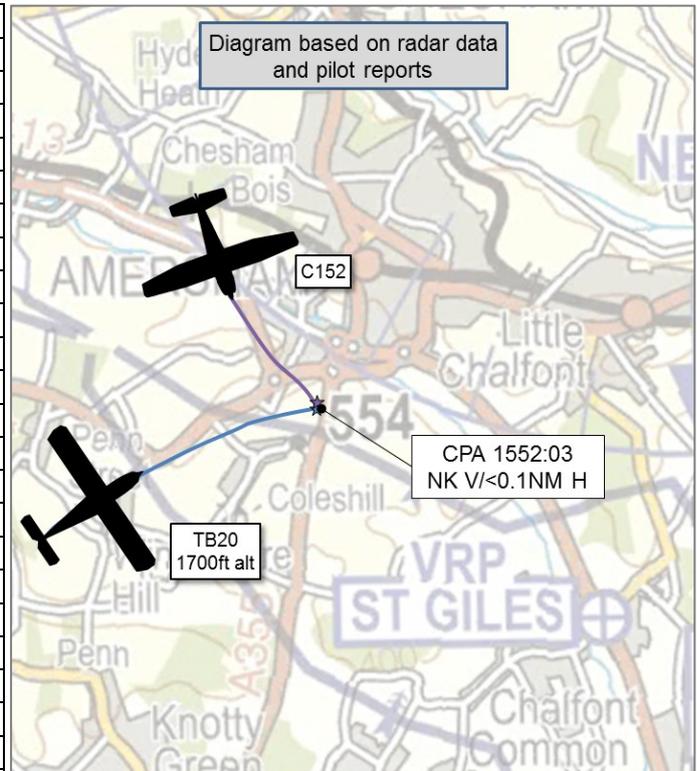
Recorded	Aircraft 1	Aircraft 2
Aircraft	TB20	C152
Operator	Civ FW	Civ FW
Airspace	London FIR	London FIR
Class	G	G
Rules	VFR	VFR
Service	Basic	Unknown ¹
Provider	Farnborough	Unknown
Altitude/FL	1700ft	NK
Transponder	A, C, S	A ²
Reported		
Colours	Red, White	White, Red, Blue
Lighting	Landing, Beacon	Strobe, Beacon
Conditions	VMC	VMC
Visibility	8km	8km
Altitude/FL	1800ft	2200ft
Altimeter	QNH (1028hPa)	QNH (1028hPa)
Heading	050°	Southerly
Speed	120kt	95kt
ACAS/TAS	PilotAware	Not fitted
Alert	None	N/A
Separation		
Reported	200ft V/200m H	Not seen
Recorded	NK V/<0.1NM H

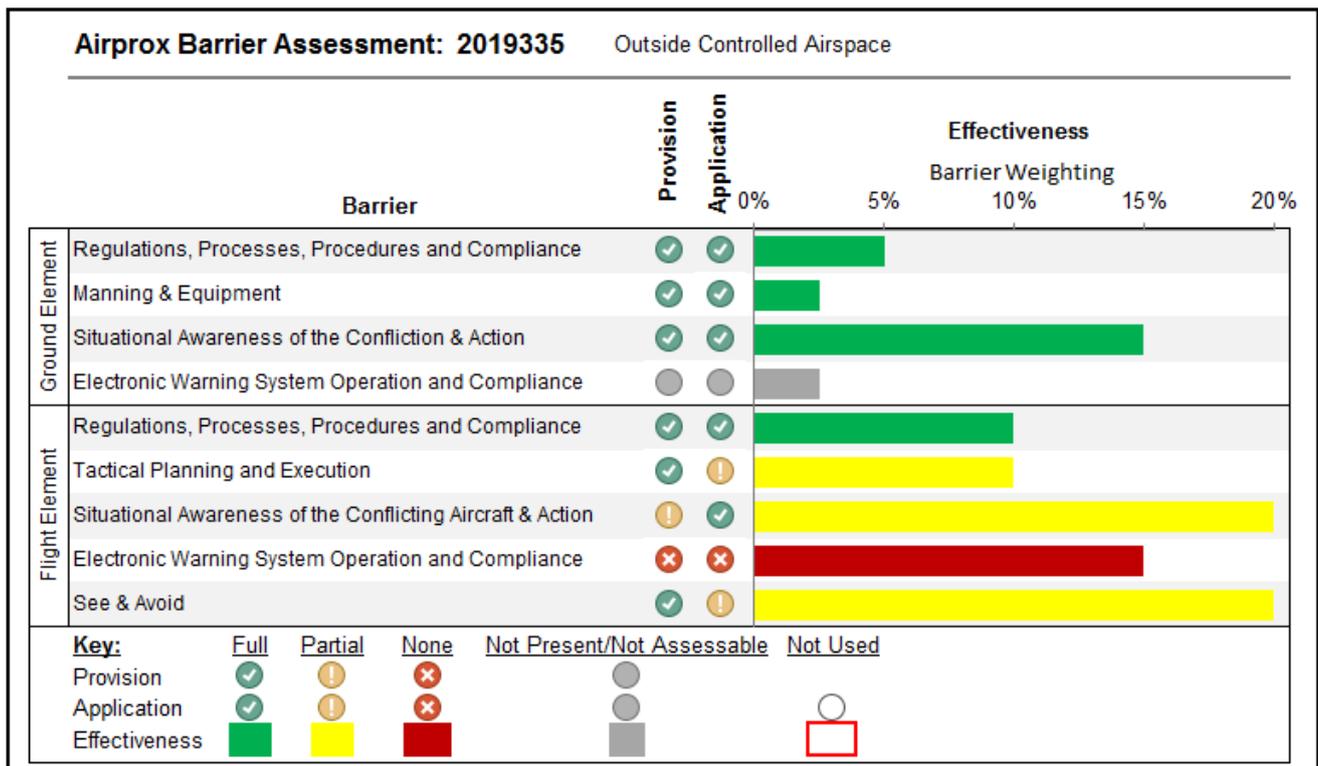
See and Avoid were assessed as **partially effective** because the C152 pilot did not see the TB20 and the TB20 pilot saw the C152 later than desirable.
