AIRPROX REPORT No 2020025

Date: 02 Mar 2020 Time: 1650Z Position: 5056N 00046W Location: South Downs

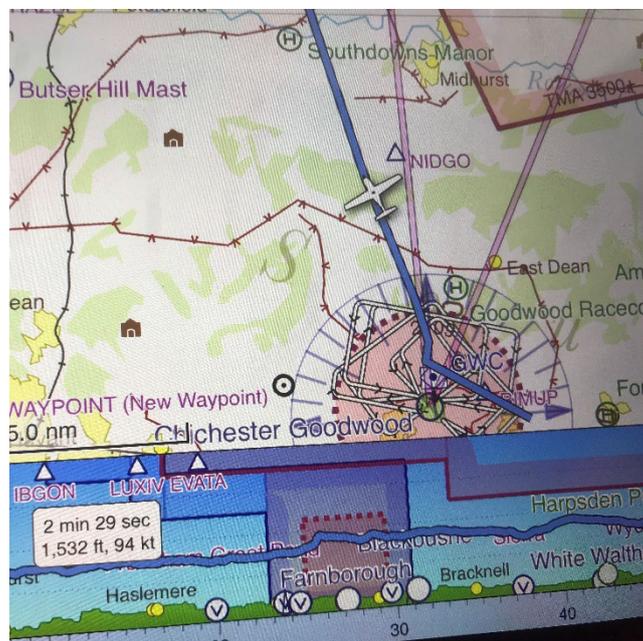
Figure 2

THE AS350 PILOT reports that they were in the cruise with both pilots looking out, flying between 1500-1700ft QNH to avoid the common altitudes. They saw a Chinook in the 11 o'clock position, low-level, flying on an easterly direction along the ridge line of the northern edge of the South Downs. The PF commented to the PM on the excellent camouflage against the forest back drop and that it was perhaps not a good place to be as that area is popular with hang-gliders and microlights. However, they did not perceive there to be a conflict, they observed the Chinook pass ahead from the 11 o'clock to the 1 o'clock approximately 1000ft below. The pilot provided a screenshot of his SkyDemon route, see Figure 1. A further screenshot provided (Figure 2) indicated the height of the AS350 at 1532ft, 2min and 29sec after take-off (which had been at 1647Z), at the point they assessed they passed overhead the Chinook.
