## AIRPROX REPORT No 2020050

Date: 04 Jun 2020 Time: 1010Z Position: 5126N 00106W Location: 4NM WSW of Reading

### PART A: SUMMARY OF INFORMATION REPORTED TO UKAB

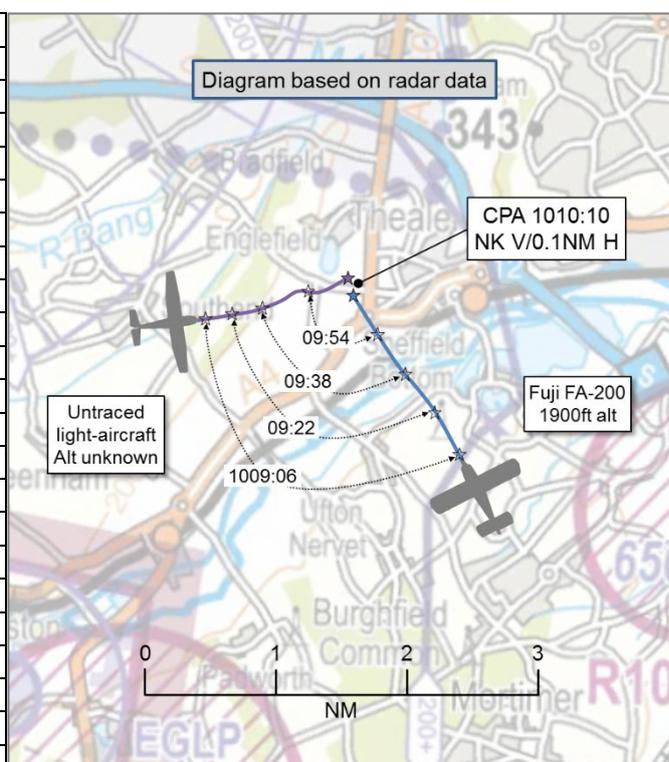
Recorded	Aircraft 1	Aircraft 2
Aircraft	Fuji FA-200	Untraced light ac
Operator	Civ FW	Unknown
Airspace	London FIR	London FIR
Class	G	G
Rules	VFR	
Service	Basic	Unknown
Provider	Farnborough LARS	
Altitude/FL	1900ft	
Transponder	A, C, S	Nil
<b>Reported</b>		
Colours	White/Blue	NK
Lighting	NR	NK
Conditions	VMC	VMC
Visibility	>10Km	NK
Altitude/FL	2000ft	NK
Altimeter	QNH (1004hPa)	NK
Heading	315°	NK
Speed	91kt	NK
ACAS/TAS	PilotAware	Unknown
Alert	None	N/A
<b>Separation</b>		
Reported	80ft V/0.25NM H	NK
Recorded	NK V/0.1NM H
