AIRPROX REPORT No 2020057

Date: 01 Jul 2020 Time: 1337Z Position: 5106N 00213W Location: 2NM SE Warminster

PART A: SUMMARY OF INFORMATION REPORTED TO UKAB

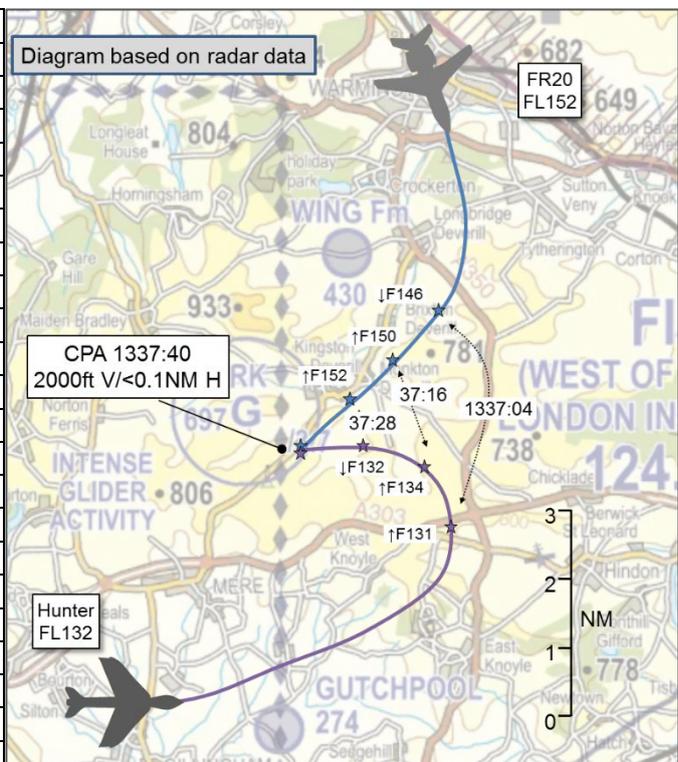
Recorded	Aircraft 1	Aircraft 2
Aircraft	FR20	Hunter
Operator	Civ Comm	Civ Comm
Airspace	London FIR	London FIR
Class	G	G
Rules	IFR	VFR
Service	Traffic	Traffic
Provider	Swanwick(Mil)	Boscombe Down
Altitude/FL	FL132	FL152
Transponder	A, C, S	A, C, S
Reported		
Colours	Blue, White	White, Blue, Gold
Lighting	HISLs, Nav	NK
Conditions	VMC	VMC
Visibility	50km	10km
Altitude/FL	FL140	FL100
Altimeter	1013hPa	1013hPa
Heading	240°	270°
Speed	220kt	NK
ACAS/TAS	TCAS II	TAS
Alert	RA	Unknown
Separation		
Reported	1000ft V/0m H	1000ft V/0m H
Recorded	2000ft V/<0.1NM H
