AIRPROX REPORT No 2020082

Date: 29 Jul 2020 Time: 1126Z Position: 5212N 00027W Location: 4NM N of Bedford

PART A: SUMMARY OF INFORMATION REPORTED TO UKAB

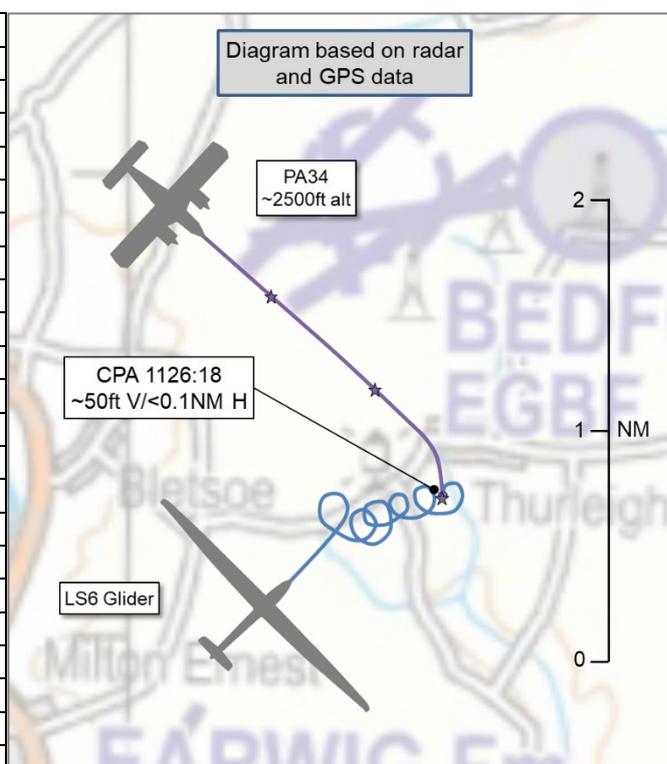
Recorded	Aircraft 1	Aircraft 2
Aircraft	LS6 glider	PA34
Operator	Civ Gld	Civ FW
Airspace	London FIR	London FIR
Class	G	G
Rules	VFR	IFR
Service	None	Procedural
Provider	N/A	Cranfield
Altitude/FL	2500ft	2450ft
Transponder	Not fitted	A, C, S
Reported		
Colours	White	Blue/white
Lighting	NR	Strobes
Conditions	VMC	VMC
Visibility	NR	'Good'
Altitude/FL	2500ft	2300ft
Altimeter	NK	QNH
Heading	180°	NR
Speed	50kt	130kt
ACAS/TAS	Unknown	Unknown
Separation		
Reported	10ft V/0NM H	Not Seen
Recorded	~50ft V/<0.1NM H

THE LS6 GLIDER PILOT reports flying a cross-country task. They had been established in a weak thermal climb for several turns when, while facing south, a powered aircraft flew directly beneath them from behind, heading roughly north-to-south. The proximity was very close, perhaps measured in feet. The aircraft was close enough such that its outline filled the canopy of their glider. They were able to see that the aircraft had twin engines and was white in colour with dark red or brown markings. They were unable to see any identification markings on the aircraft due to its position directly beneath them. They are familiar and comfortable with glider aerotow procedures, which use ropes 180-200ft in length, so they are well aware of how a powered aircraft in flight 'should' look from that distance. This Airprox was dramatically closer than that. After a few minutes, they were able to continue with their task for a short time, but the shock of the occurrence was enough to persuade them to return to [their destination] where they made a safe landing.
