**AIRPROX REPORT No 2020136**

Date: 11 Sep 2020 Time: 1427Z Position: 5043N 00325W Location: Exeter Airport – elev 102ft

**PART A: SUMMARY OF INFORMATION REPORTED TO UKAB**

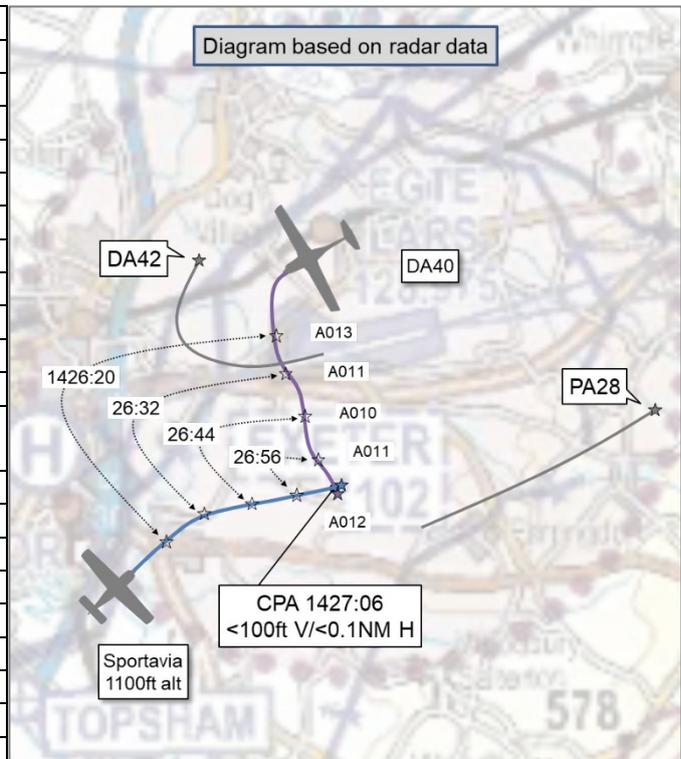
**THE SPORTAVIA PILOT** reports returning to Exeter Airport when, about 10 miles out, another pilot was heard on the Exeter Radar frequency saying they were inbound; 2 other aircraft were also heard on frequency. The impression was formed, from the other pilot’s radio calls, that they might not be experienced or adept, so a mental note was made to take extra care in the circuit if they were going to be there simultaneously. The Tower was contacted for joining instructions and clearance given for a left-hand downwind join for RW26. As the clearance was passed the inbound pilot declared the intention for an overhead join for the same runway. The inbound pilot was instructed to descend deadside while the Sportavia pilot joined downwind. The controller told the joining pilot to keep a lookout for other aircraft in the circuit; one was another private flight on left base and the other a commercial light twin on long finals, about 10 miles out. The Sportavia pilot joined downwind as instructed, at the correct circuit height and on the correct reciprocal heading for the runway, and called downwind as they came abeam the upwind end of the runway, all the time keeping an eye out to the left for the other aircraft after its deadside descent. The Sportavia pilot anticipated that the other aircraft would cross the upwind end of the runway, somewhere astern, but instead it was (perceived as being) in the 10:30 position at the same level, crossing the runway half-way along its length at 90°. There was no relative motion, so it was apparent that they were on a collision course. The controller asked the other pilot whether they were visual, but by this time the Sportavia pilot assumed this was not the case, took evasive action and reported that they had seen him and that they were descending. After turning gently left and descending to attempt to pass under the other aircraft’s tail, the Sportavia pilot distinctly remembered looking vertically upwards through the bubble canopy and seeing the other aircraft about 100ft almost directly above, crossing left to right. The whole incident from first sighting to passing under him took less than ten seconds. The Sportavia pilot stated that they strongly feel that the situation had been resolved by the instinctive mistrust of the other pilot, based entirely on a gut feeling from their radio calls, the wariness that this engendered, and the subsequent SA to know where to look if there was going to be

a threat if they got their positioning wrong, which was the case. The joining aircraft should have been half a mile behind, joining crosswind, not crossing his path halfway along the downwind leg.

**THE DA40 STUDENT PILOT** reports conducting a solo VFR navigation training sortie to Exeter Airport and return, to practise VFR navigation techniques, a Standard Overhead Join (SOJ) and touch-and-go. This was their first solo flight to Exeter, having previously flown a similar sortie dual. The enroute phase of the sortie went as planned. The current airfield and meteorological conditions were obtained from ATIS prior to contacting Exeter Radar, the QNH and ATIS information code was acknowledged on initial contact and a SOJ requested. They were handed over to Tower on entering the Exeter ATZ and arrived at the overhead at 2100ft QNH, tracking north over the threshold markings of RW26 towards the deadside. Shortly after entering the deadside the Tower controller instructed the DA40 student pilot to complete 2 right-hand orbits to allow a twin-engine aircraft to perform a low approach and go-around. The Tower controller was informed once complete and further clearance to continue descending deadside was issued. They levelled at 1100ft at the beginning of the crosswind leg and were passed Traffic Information and instructed to report traffic in sight. The DA40 student pilot recalled that the traffic was in a position to the right but could not recall whether the Tower controller reported the altitude of the other aircraft. The instruction to report traffic in sight was acknowledged and lookout continued but not yet in visual contact. Shortly afterwards, whilst still on the crosswind leg, updated Traffic Information was received, 'about to pass right-to-left', and the DA40 student pilot was asked again whether they were visual. They confirmed traffic in sight just as the other aircraft passed directly beneath, from right to left. There was no time to take avoiding action. They thought the other aircraft had joined downwind. The DA40 student pilot noted that, to the best of his knowledge, the DA40 was fitted with a fully serviceable transponder and a Traffic Awareness System (TAS) which gave audio and visual Traffic Advisories. They could not recall an audio or visual TAS alert. They noted that the workload was high and the focus was to fly the airplane in accordance with the SOJ procedure whilst looking for other aircraft.

The Exeter Airport Occurrence Investigation found that the incident had been caused because the DA40 pilot did not use the Traffic Information provided by the Tower controller to adjust his path to integrate safely into the circuit traffic, although the reason for that was unknown. The investigation found that a contributing factor had been that the Tower controller was inconsistent in how the traffic sequence was managed and communicated to the DA40 pilot. The Tower controller informed the DA40 pilot that he was 'number 2' to the DA42, carrying out an instrument approach, and held him in the overhead for spacing. However, after Traffic Information was passed on 2 aircraft joining left-hand downwind, the controller cleared the DA40 pilot to descend on the dead side but now expected the pilot to integrate with the joining traffic and sequence himself.
