AIRPROX REPORT No 2020152

Date: 22 Oct 2020 Time: 1017Z Position: 5216N 00033W Location: 2NM SE of Rushden

PART A: SUMMARY OF INFORMATION REPORTED TO UKAB

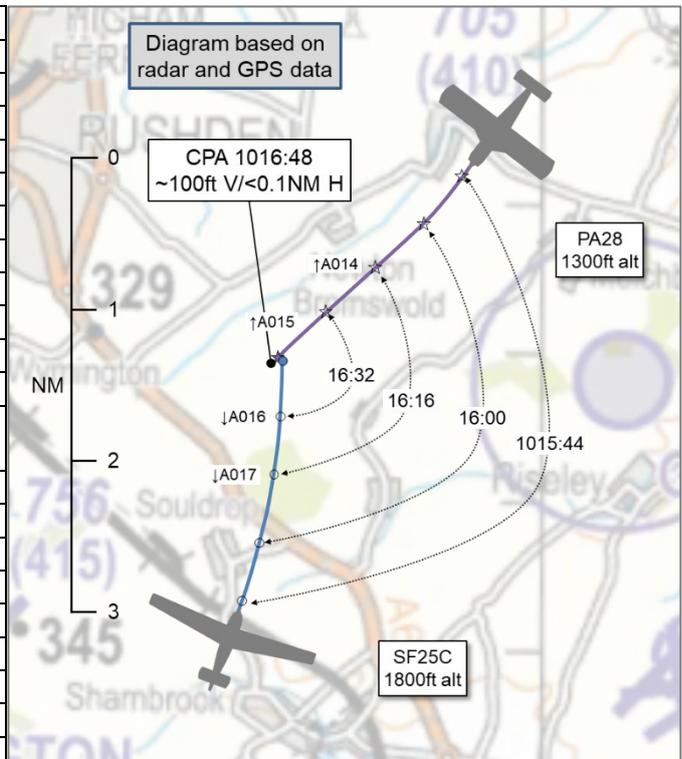
Recorded	Aircraft 1	Aircraft 2
Aircraft	SF25C motor-glider	PA28
Operator	Civ FW	Civ FW
Airspace	London FIR	London FIR
Class	G	G
Rules	VFR	VFR
Service	None	Basic
Provider	N/A	Sywell Information
Altitude/FL	1600ft ¹	1500ft
Transponder	Not fitted	A, C, S
Reported		
Colours	Yellow, black	White
Lighting	Strobe	Strobes, beacon, nav lights
Conditions	VMC	VMC
Visibility	10km	10km
Altitude/FL	1600ft	NR
Altimeter	QNH (1008hPa)	QNH
Heading	005°	NR
Speed	80kt	120kt
ACAS/TAS	PilotAware/FLARM	Not fitted
Alert	Information	N/A
Separation		
Reported	200ft V/0m H	NR V/0m H
Recorded	~100ft V/<0.1NM H
