AIRPROX REPORT No 2020018

Date: 12 Feb 2020 Time: 1605Z Position: 5302N 00031W Location: RAF Cranwell circuit

PART A: SUMMARY OF INFORMATION REPORTED TO UKAB

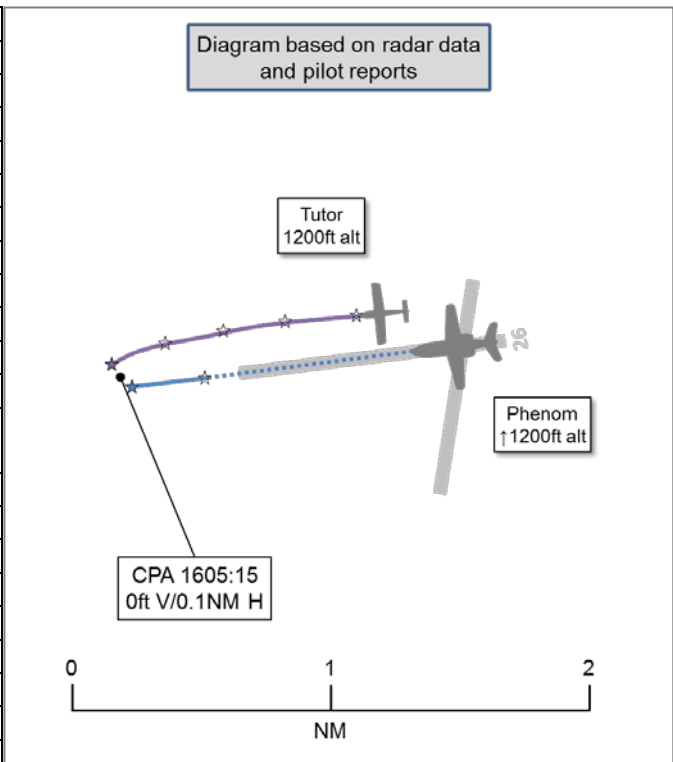
Recorded	Aircraft 1	Aircraft 2
Aircraft	Phenom	Tutor
Operator	HQ Air (Trg)	HQ Air (Trg)
Airspace	RAF Cranwell ATZ	RAF Cranwell ATZ
Class	G	G
Rules	VFR	VFR
Service	ACS	ACS
Provider	Cranwell Tower	Cranwell Tower
Altitude/FL	1200ft	1200ft
Transponder	A, C, S	A, C, S
Reported		
Colours	Blue/White	White
Lighting	Nav, Strobes, Taxi light	HISLs, Nav lights
Conditions	VMC	VMC
Visibility	9.9km	10km
Altitude/FL	750ft	800ft
Altimeter	QFE (1004hPa)	QFE (1004hPa)
Heading	264°	264°
Speed	180kt	80kt
ACAS/TAS	TCAS II	TAS
Alert	None	Unknown
Separation		
Reported	50-100ft V/0m H	50-100ft V/0m H
Recorded	0ft V/0.1NM H

Although the CPA is measured at 0ft V and 0.1NM H, it should be noted that this particular radar sweep was while the Phenom pilot was in the process of arresting his climb and descending – one sweep of the radar (4sec) later, the separation is recorded as 400ft V and <0.1NM H.
