AIRPROX REPORT No 2020027

Date: 13 Mar 2020 Time: 1110Z Position: 5302N 00046W Location: 2NM S Newark

PART A: SUMMARY OF INFORMATION REPORTED TO UKAB

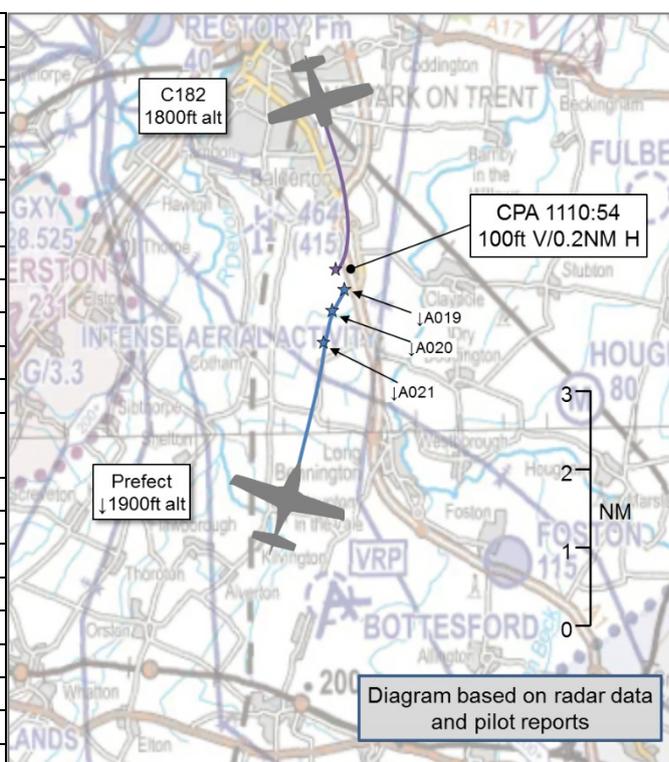
Recorded	Aircraft 1	Aircraft 2
Aircraft	Prefect	C182
Operator	HQ Air (Trg)	Civ FW
Airspace	London FIR	London FIR
Class	G	G
Rules	VFR	VFR
Service	Traffic	Listening Out
Provider	Cranwell App	East Midlands
Altitude/FL	1800ft	1900ft
Transponder	A,C,S	A,C,S
Reported		
Colours	White	White, Green
Lighting	NR	Strobes, Flashing LED Tail, Beacon
Conditions	VMC	VMC
Visibility	25km	>20NM
Altitude/FL	2000ft	2000ft
Altimeter	QNH (1012hPa)	QNH (1009hPa)
Heading	015°	195°
Speed	100kt	120kt
ACAS/TAS	TAS	Not fitted
Alert	TA	N/A
Separation		
Reported	30ft V/0.5NM H	300-400ft V/800-1000m H
Recorded	100ft V/0.2NM H

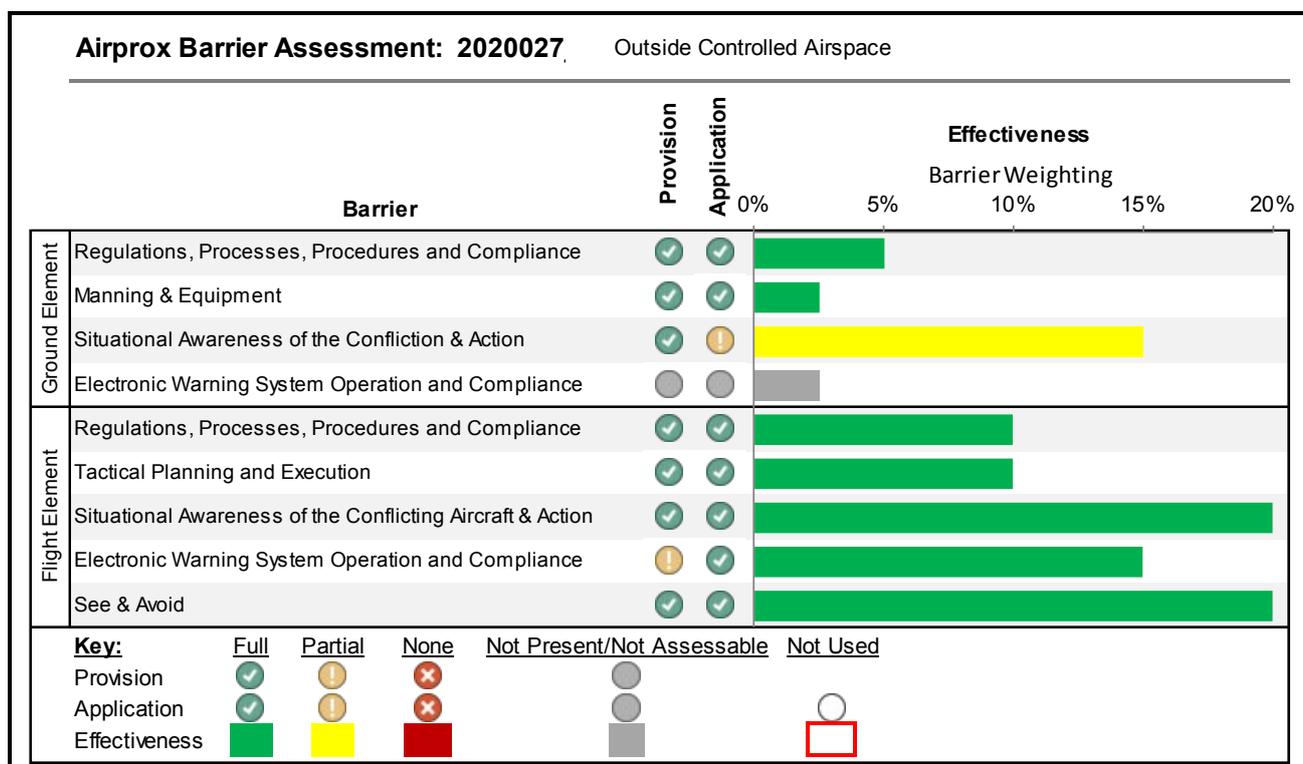
Ground Elements:

Situational Awareness of the Confliction and Action were assessed as **partially effective** because workload and the RT loading was such that the controller could not make an earlier Traffic Information call to the Prefect pilot.
