AIRPROX REPORT No 2020032

Date: 17 Mar 2020 Time: 1657Z Position: 5156N 00216W Location: 5NM NW Gloucester

PART A: SUMMARY OF INFORMATION REPORTED TO UKAB

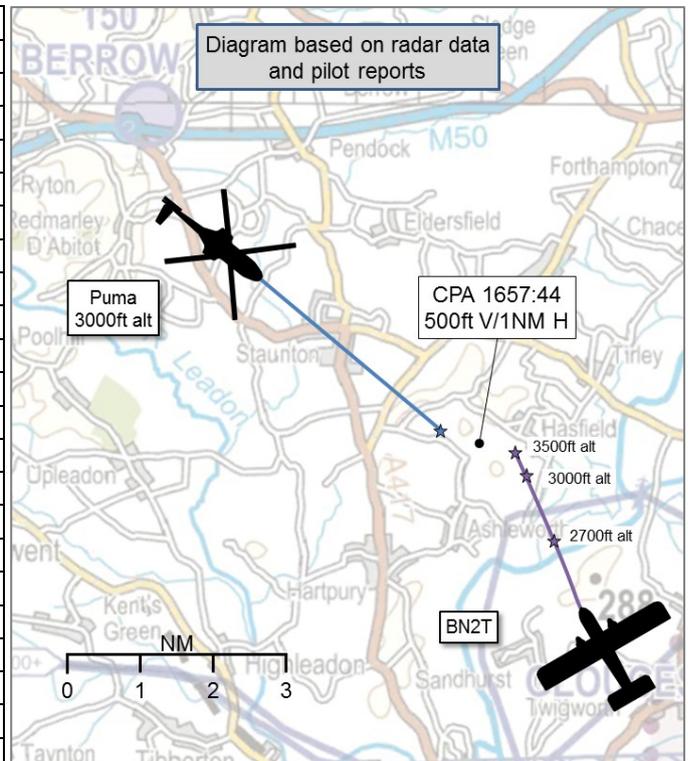
Recorded	Aircraft 1	Aircraft 2
Aircraft	Puma	BN2T
Operator	HQ JHC	Civ Comm
Airspace	London FIR	London FIR
Class	G	G
Rules	IFR	IFR
Service	Traffic	Procedural
Provider	Brize	Gloster
Altitude/FL	3000ft	3000ft
Transponder	A, C, S	A, C
Reported		
Colours	Green	White, Red, Blue
Lighting	Nav, Landing	Anti-Col, Fin, Nav
Conditions	IMC	VMC
Visibility	Not reported	10km
Altitude/FL	3000ft	4000ft
Altimeter	NK	QNH
Heading	140°	340°
Speed	120kt	100kt
ACAS/TAS	TAS	TCAS I
Alert	TA	TA
Separation		
Reported	Not seen (IMC)	500ft V/1NM H
Recorded	500ft V/1NM H

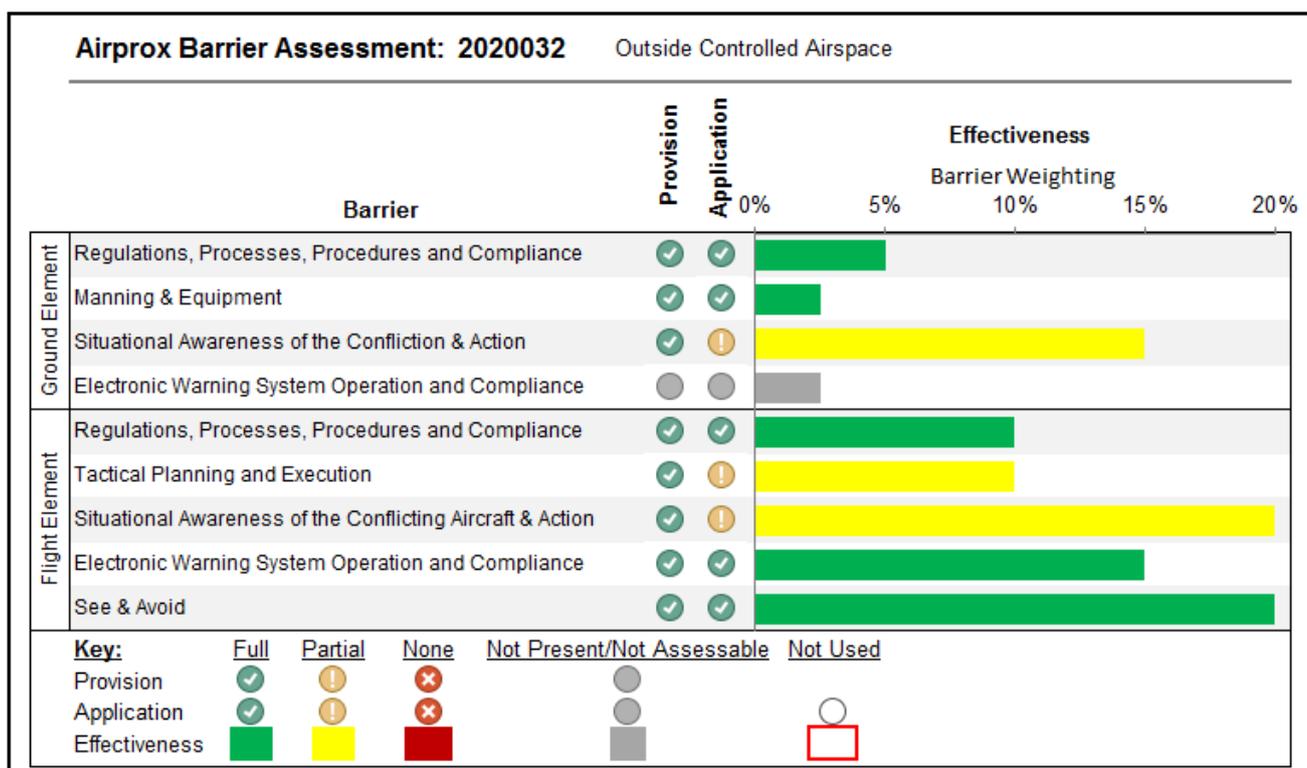
Tactical Planning and Execution was assessed as **partially effective** because the Puma pilot did not restate their request for a Deconfliction Service from the Brize controller when operating in IMC.

Situational Awareness of the Conflicting Aircraft and Action were assessed as **partially effective** because the Puma pilot did not act sufficiently on the Traffic Information provided by the Brize controller until they received a TAS alert.
