AIRPROX REPORT No 202040

Date: 20 May 2020 Time: 1230Z Position: 5145N 00110W Location: 1.5NM NE Oxford

PART A: SUMMARY OF INFORMATION REPORTED TO UKAB

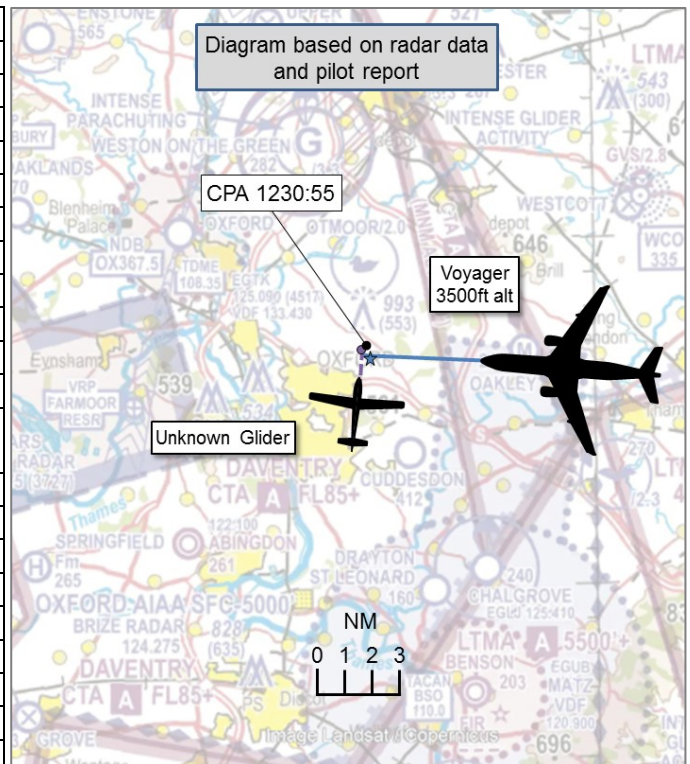
The Voyager was returning to Brize from an overseas flight and being positioned for the ILS approach to RW25 at Brize. Whilst in the descent to altitude 2800ft, the Voyager pilot reported passing a glider by an estimated $\frac{1}{4}$ of a mile, slightly below, on their flight path.
