AIRPROX REPORT No 2020045

Date: 30 May 2020 Time: 1433Z Position: 5259N 00007E Location: 4NM E of Boston

PART A: SUMMARY OF INFORMATION REPORTED TO UKAB

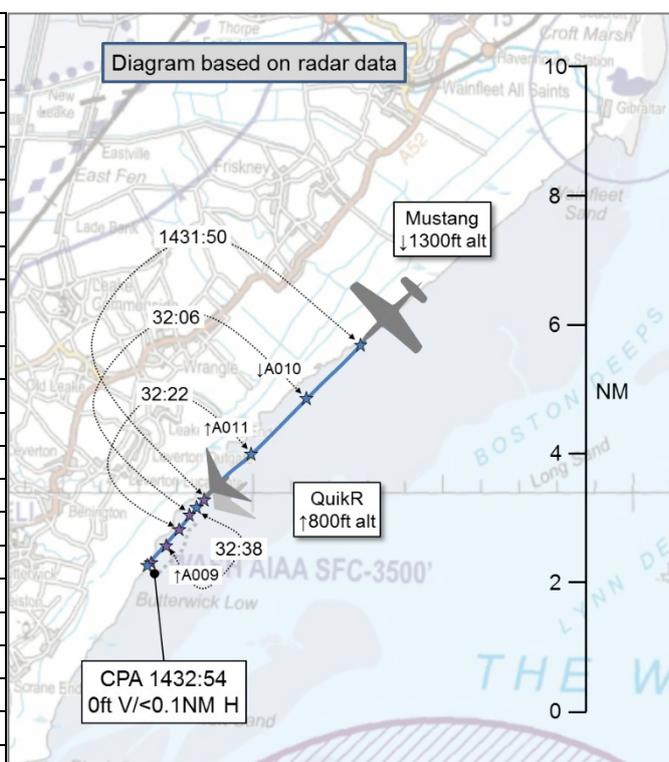
THE MUSTANG PILOT reports that they were flying along the coast, straight and level, when they sighted a weight-shift microlight just forward of the engine cowling, slightly to their left and at a distance of about 100m with no height separation; it was too late to take any avoiding action. The aircraft's track was parallel to their own and they could see that the pilot of the microlight was wearing a black flight suit and helmet. They believe that the microlight pilot was unaware of their presence and, once alongside, they noticed a second microlight approximately 70m to their left.
