AIRPROX REPORT No 2020059

Date: 14 Jun 2020 Time: 1422Z Position: 5209N 00035W Location: 5NM NNE Cranfield

PART A: SUMMARY OF INFORMATION REPORTED TO UKAB

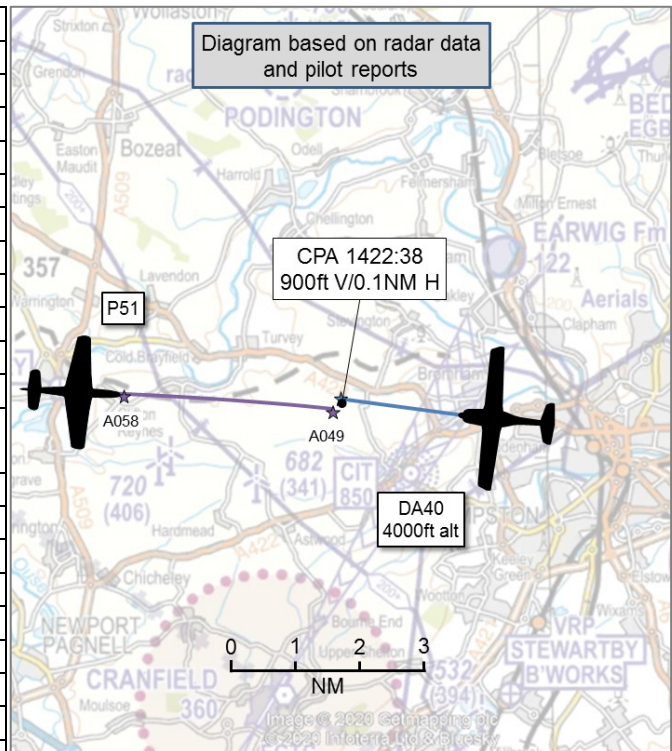
Recorded	Aircraft 1	Aircraft 2
Aircraft	DA40	P51
Operator	Civ FW	Civ FW
Airspace	London FIR	London FIR
Class	G	G
Rules	IFR	VFR
Service	Traffic	None
Provider	Oxford	N/A
Altitude/FL	4000ft	4900ft
Transponder	A, C, S	A, C, S
Reported		
Colours	White, Blue	Silver
Lighting	Strobe, Position, Landing, Taxi	Not reported
Conditions	VMC	VMC
Visibility	Not reported	Not reported
Altitude/FL	FL040	6300ft
Altimeter	QNH (1013hPa)	NK
Heading	240°	095°
Speed	120kt	230kt
ACAS/TAS	Not fitted	Unknown
Alert	N/A	Unknown
Separation		
Reported	500ft V/100m H	Not seen
Recorded	900ft V/0.1NM H
