AIRPROX REPORT No 2020060

Date: 07 Jul 2020 Time: 1310Z Position: 5036N 00436W Location: Bodmin Moor

PART A: SUMMARY OF INFORMATION REPORTED TO UKAB

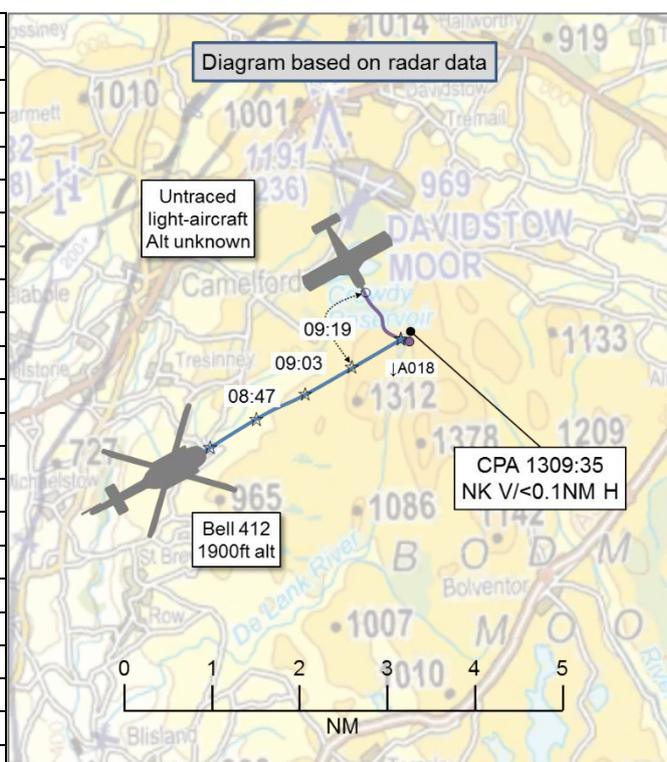
THE BELL 412 PILOT reports that they were in the cruise at 2000ft in good VMC when the instructor suddenly became aware of a white fixed-wing aircraft in close proximity to their helicopter. The instructor took control from the student and pushed the cyclic forward to descend to ensure separation was maintained, and the helicopter passed below the fixed-wing aircraft. The fixed-wing aircraft appeared from the 10 o'clock position and was hidden from view on a constant bearing behind the large cockpit frame until the last minute; the TAS Sentinel did not produce a contact or warning because, they suggest, the FW was not transponding. They advised Newquay ATC that they had come very close to another aircraft and that they would be filing an Airprox report on landing.

This encounter was reported by the Bell 412 pilot at 13:09:39, no corresponding radar return for the unknown aircraft was seen in the 10min leading up to this call, but there were briefly 2 PSR contacts seen diverging (1 SE, 1 NE) after it was made.
