AIRPROX REPORT No 2020067

Date: 14 Jul 2020 Time: 1132Z Position: 5236N 00059W Location: Leicester aerodrome

PART A: SUMMARY OF INFORMATION REPORTED TO UKAB

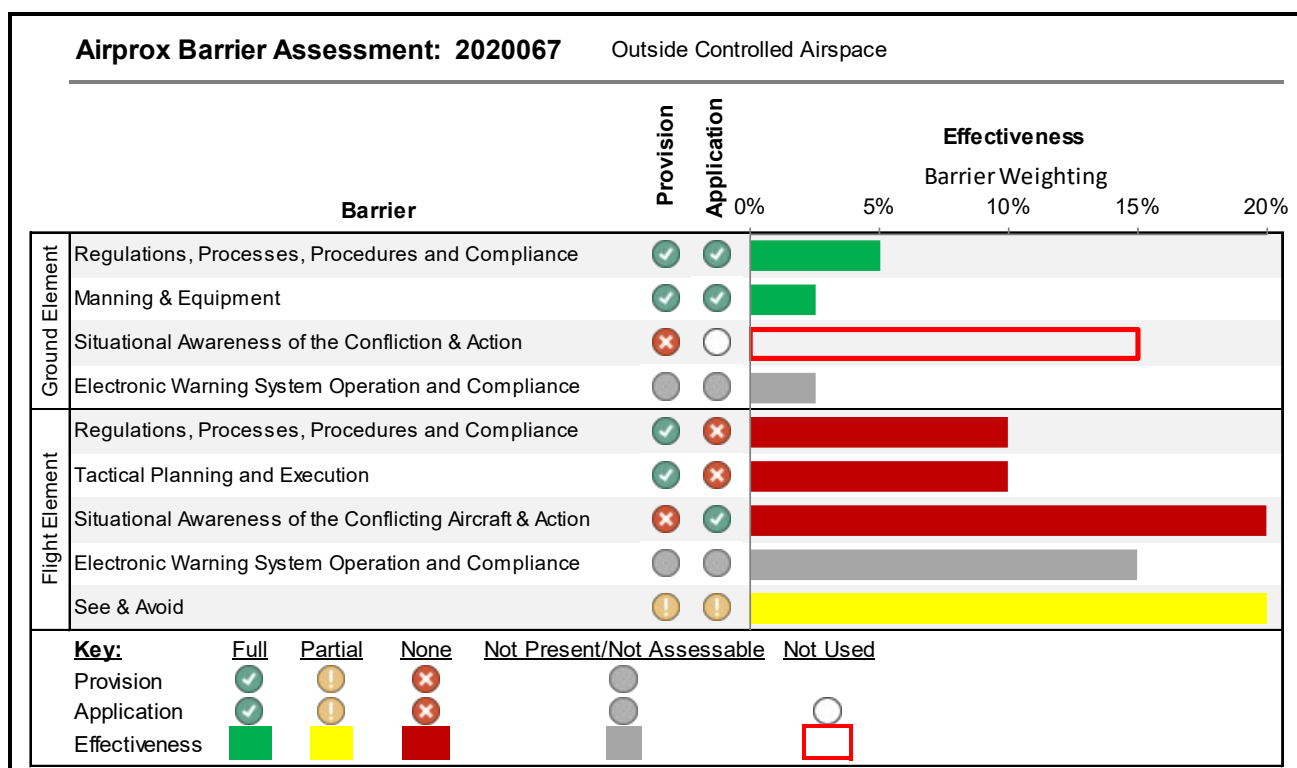
Situational Awareness of the Conflicting Aircraft and Action were assessed as **ineffective** because the Grob 115 pilot received no warning of the presence of the biplane until they sighted the aircraft.

See and Avoid were assessed as **partially effective** because the Grob 115 pilot did not see the biplane until it was effectively too late to increase the separation between the 2 aircraft.
