AIRPROX REPORT No 2020074

Date: 21 Jul 2020 Time: 1010Z Position: 5222N 00019W Location: 5NM W Alconbury

PART A: SUMMARY OF INFORMATION REPORTED TO UKAB

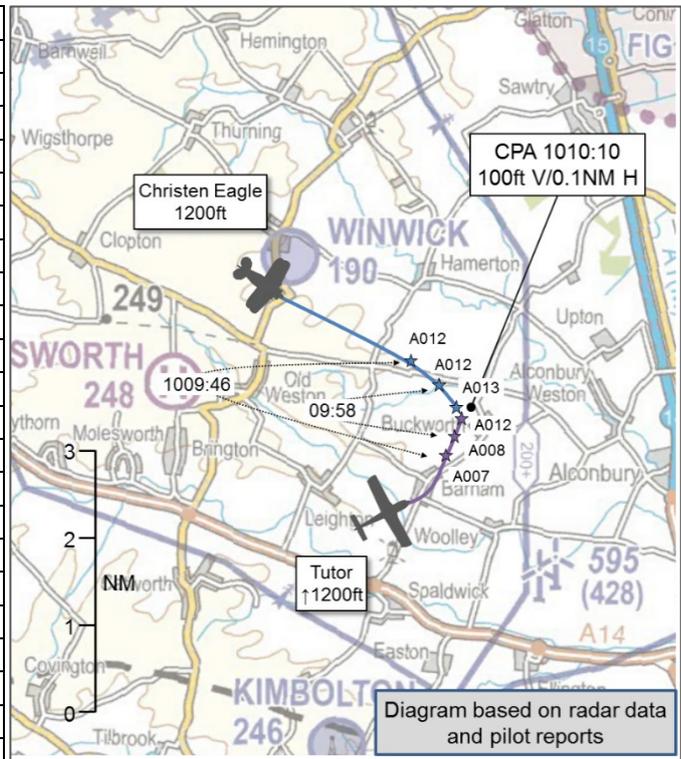
THE CHRISTEN EAGLE PILOT reports flying straight and level, assessing the balance of the aircraft at different speeds and making notes in order to make an adjustment to the fixed rudder trim tab after landing. Consequently, the pilot was checking the slip ball and looking down to make a note. This almost certainly contributed to the late sighting of the Grob. When first sighting the other aircraft, it was in the 1 o'clock position, level and moving right to left at about 250m distance. It appeared to have been approaching from a relative bearing of about 030°. At the same time as seeing the Grob, the other pilot rolled right, and the Christen Eagle pilot also rolled right. The pilot estimated that the two aircraft probably came within about 200m of each other.

THE TUTOR PILOT reports that on recovery to base, a contact was noted on TAS at about 2NM, in the 10 o'clock position. The contact was sighted visually and deemed not to be a threat. The crew maintained visual with the other aircraft and had a discussion about the fact that it looked like the other pilot had not seen their aircraft. They watched the aircraft approach and deemed that it was of no threat to the safety of their aircraft. They were in a gentle climb in order to gain height to teach side-slipping and the student was directed to turn very slightly to the right whilst maintaining level. The other pilot seemed to see them and then take very sharp avoiding action in the form of hard turn to the right and down. At no point was it assessed that the other aircraft came within in 0.5NM. On returning to base the incident was mentioned to the Duty Authoriser. No Airprox was raised at the time as it wasn't believed that the safety of the aircraft was ever threatened.
