AIRPROX REPORT No 2020095

Date: 10 Aug 2020 Time: 0941Z Position: 5238N 00250W Location: 15NM SW Shawbury

PART A: SUMMARY OF INFORMATION REPORTED TO UKAB

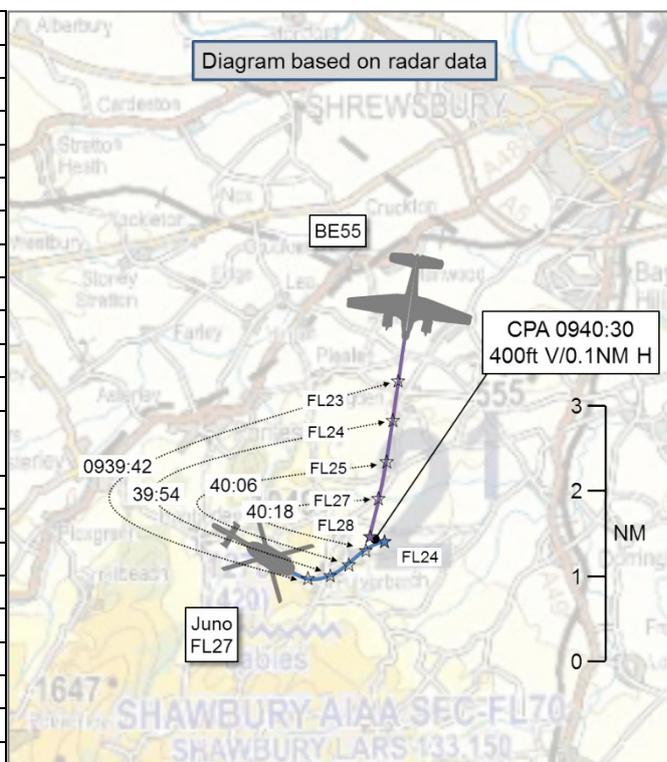
THE JUNO INSTRUCTOR reports being vectored for a PAR to RW36 when the Shawbury Approach controller alerted them to an aircraft north by 3 miles, tracking south at 300ft below and climbing. The trainee was on instruments and replied to approach controller "looking". ACAS then reported "Aircraft 10 o'clock, less than 1 mile." The aircraft in question was initially obscured by the door frame but when sighted it was apparent they were at the same level and their paths would become dangerously close if track was maintained. The Instructor took control and began a rapid descent, informing Approach of the avoiding action manoeuvre. The other aircraft tracked above from the 10 to 4 o'clock and did not appear to take any avoiding action. The Instructor noted that Shawbury Approach was extremely busy during this time and, due to the potential dangers of non-Shawbury traffic, Shawbury Zone frequency was monitored as well. At the time the incident took place, the controller was transmitting to another aircraft.

THE BE55 PILOT reports that he was in the climb having left the departure airfield. Nothing was reported by the controller and the reporting helicopter was not seen. The BE55 pilot noted that he was using a VHF radio, the Juno was using a UHF radio and that mixing aircraft in the same airspace who cannot hear each other is a problem.

The RAF Shawbury Local Investigation found that the cause was a natural operating hazard and that ATC and ACAS had warned the Juno pilot [of the converging BE55], with a contributory factor that one of the Juno pilots was flying on instruments which reduced the options for lookout.
