AIRPROX REPORT No 2020112

Date: 05 Sep 2020 Time: 1331Z Position: 5058N 00156W Location: 7NM east Compton Abbas

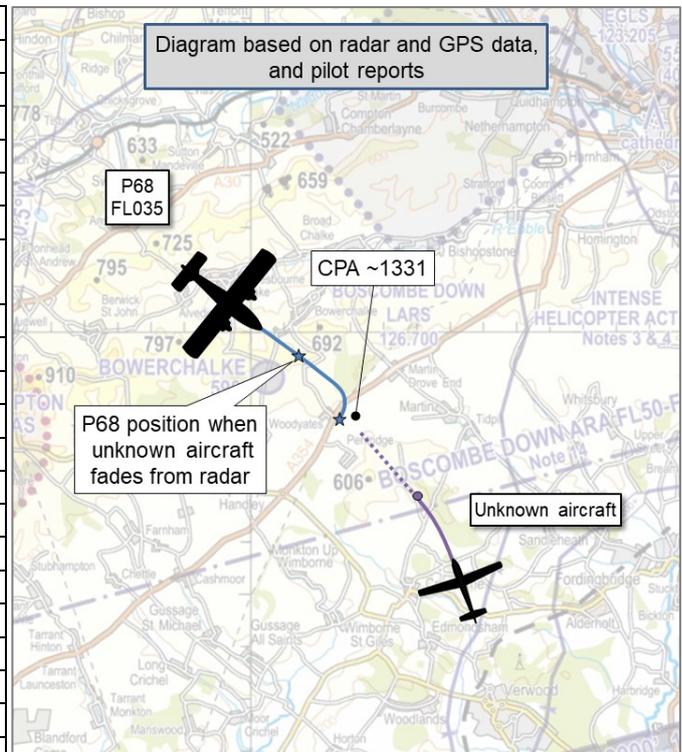
Recorded	Aircraft 1	Aircraft 2
Aircraft	P68	Unknown glider
Operator	Civ Comm	Civ Gld
Airspace	London FIR	London FIR
Class	G	G
Rules	VFR	VFR
Service	None	
Provider	Changing frequency	
Altitude/FL	FL035	
Transponder	A, C, S	
Reported		
Colours	White, Blue	
Lighting	Strobe, Nav	
Conditions	VMC	
Visibility	>10km	
Altitude/FL	3700	
Altimeter	QNH	
Heading	190°	
Speed	130kt	
ACAS/TAS	Not fitted	Unknown
Separation		
Reported	60ft V/50-75m H	NK
Recorded	NK

THE P68 PILOT reports that they had just finished surveying and were heading towards their destination. After requesting a frequency change from London Info and while inputting the new frequency they suddenly noticed a glider, wings level, at what appeared to be the same altitude, in their 10-11 o'clock flying towards them. The autopilot was disconnected, and a right turn commenced in order to diverge. Whilst turning, they noticed the oncoming traffic commencing a turn to its right approximately 3-4 seconds after they had commenced their turn.

The pilot assessed the risk of collision as 'High'.
