AIRPROX REPORT No 2020116

Date: 12 Sep 2020 Time: 1229Z Position: 5119N 00048W Location: Blackbushe

PART A: SUMMARY OF INFORMATION REPORTED TO UKAB

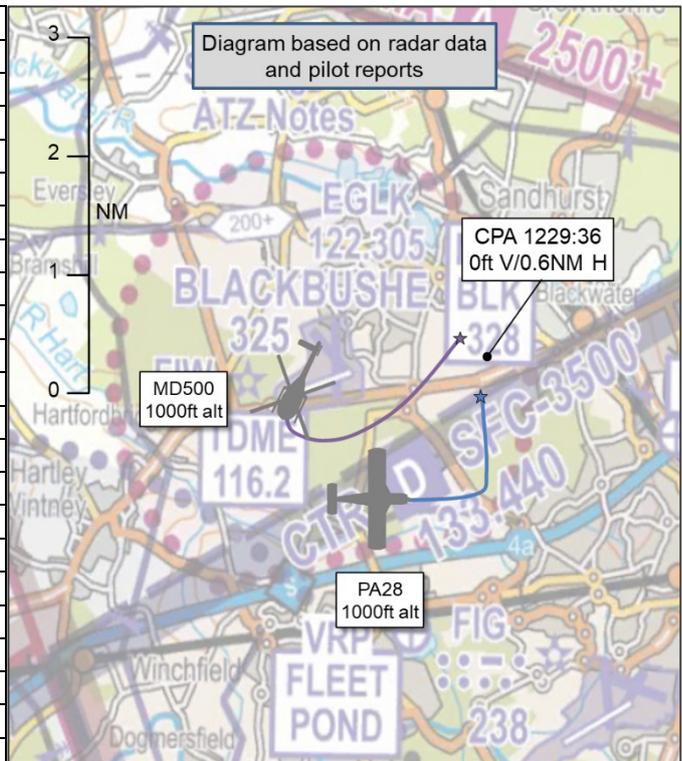
Recorded	Aircraft 1	Aircraft 2
Aircraft	PA28	MD500
Operator	Civ FW	Civ Helo
Airspace	Blackbushe ATZ	Blackbushe ATZ
Class	G	G
Rules	VFR	VFR
Service	AFIS	AFIS
Provider	Blackbushe	Blackbushe
Altitude/FL	1000ft	1000ft
Transponder	A, C, S	A, C, S
Reported		
Colours	White, Blue	NR
Lighting	Landing, Strobe	NR
Conditions	VMC	VMC
Visibility	NK	NR
Altitude/FL	700ft	NR
Altimeter	QNH	QNH
Heading	340°	NR
Speed	75kt	NR
ACAS/TAS	Not fitted	Unknown
Alert	N/A	Unknown
Separation		
Reported	0ft V/1000m H	NR
Recorded	0ft V/0.6NM H
