## AIRPROX REPORT No 2020122

Date: 14 Sep 2020 Time: 1107Z Position: 5126N 00118W Location: 1.5NM NE of Newbury

### PART A: SUMMARY OF INFORMATION REPORTED TO UKAB

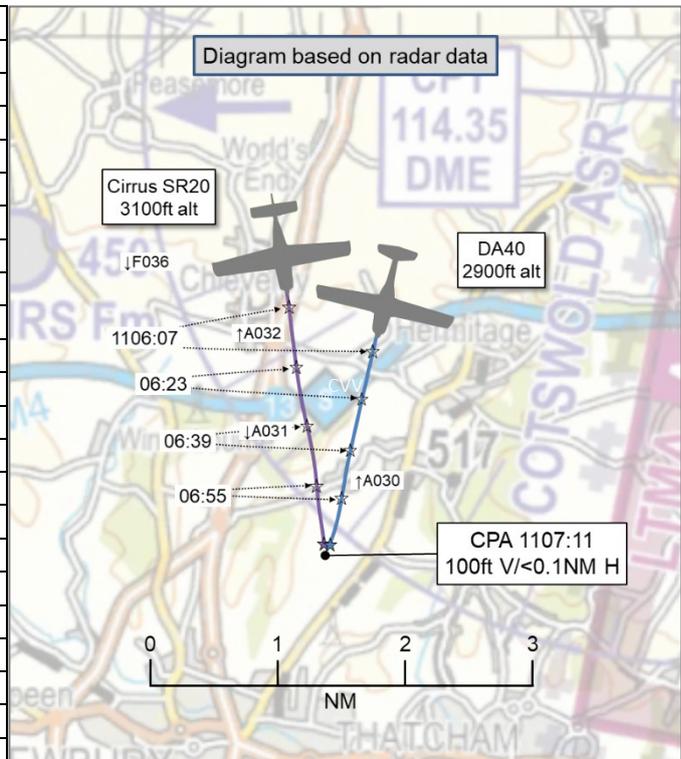
**THE DA40 PILOT** reports that the Cirrus SR20 was converging from approximately their 4-5 o'clock; it was faster and overtaking on their right-hand side. The aircraft was not spotted until they were informed by ATC "aircraft right, same level half a mile converging" or a call similar to that. Immediately on looking over their right shoulder they spotted the SR20 at a range of 150-200m. They briefly hesitated before commencing a descending left turn. In order to spot the aircraft, they were required to lean forward to clear the canopy structure from the far right of their view due to it approaching from the rear. This may have resulted in them missing the aircraft in a scan. The student in the left-hand seat of the aircraft had just set the Portland regional QNH which differed by 5hPa from the previous Oxford QNH. The instructor glanced over to check the new pressure setting had been set at the time the Traffic Information was passed.

With the position of the aircraft approaching from the rear on the right-hand side of the aircraft, their student in the left-hand seat would probably not have been able to see the aircraft due to the structure of the DA40. Their rear-seat student was also on the rear-left of the aircraft and, due to the structure of the DA40, they do not believe that they would have been able to see the aircraft either. The instructor personally did not sight the aircraft until informed by ATC. After spotting it, they do not feel that they would have hit on their current courses. However, they feel that it would have been very close and safety was degraded. They are not sure if the SR20 pilot spotted them or not. Their courses were slowly converging at a similar level.

**THE CIRRUS SR20 PILOT** reports being in the cruise at 3000ft with the autopilot engaged, en-route to [their destination] with a passenger who is also a qualified pilot. They had previously been in contact with Brize Norton for a CTR crossing and were preparing to contact Solent Radar. They had watched an aeroplane on the MFD map (displayed by TAS) climb behind them and level off 100ft below and to their left, heading in the same direction. They had a TAS contact for some time prior to the TA. They visually acquired the conflicting DA40 traffic on their left and climbed to 3200ft to diverge from it whilst maintaining visual separation. They then watched the DA40 diverge on a south-easterly heading before turning right towards them again just to the north of Newbury [UKAB Note: the NATS radar replay showed this turn occurring at 1104:18]. They then monitored the DA40 visually until it became clear to them that the DA40 pilot had not seen them; they turned right to make their aeroplane more visible and ensure separation both laterally and vertically.

them and level-off 100ft below, to their left, heading in the same direction. As the conflicting aircraft accelerated, the SR20 pilot received a TAS Traffic Alert. They visually acquired the DA40 on their left at 1NM and climbed to diverge whilst maintaining visual separation. They then observed the DA40 diverge on a south-easterly heading before turning right towards them; at this point the SR20 pilot turned right to make their aircraft more visible and ensure lateral and vertical separation. Estimated separation was reported as 100ft vertically and 500m horizontally and they reported no risk of collision.
