AIRPROX REPORT No 2020124

Date: 16 Sep 2020 Time: 1029Z Position: 5207N 00146W Location: 1NM SW Long Marston

PART A: SUMMARY OF INFORMATION REPORTED TO UKAB

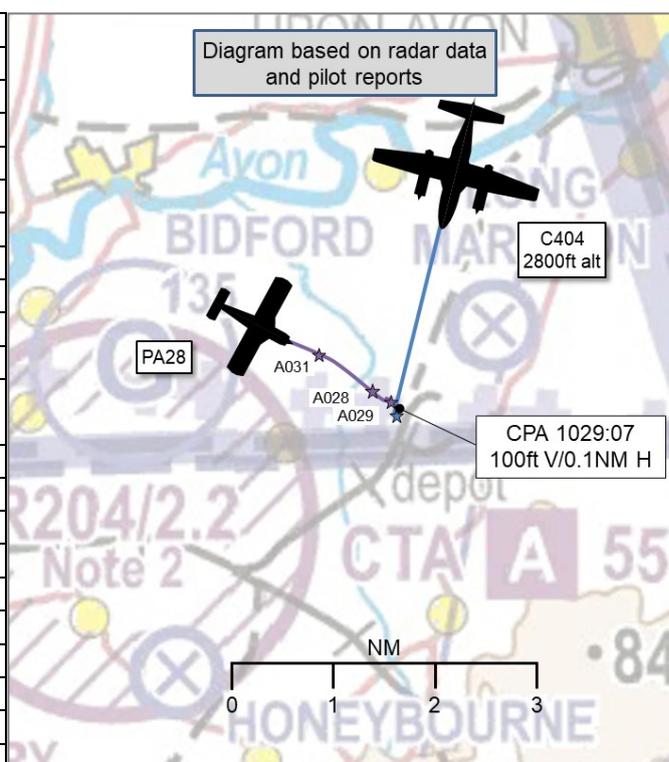
| Recorded | Aircraft 1 | Aircraft 2 |
|---|---|---|
| Reported | 300ft V/0.25NM H | 400ft V/1NM H |
| Recorded | 100ft V/0.1NM H | |
