## AIRPROX REPORT No 2020151

Date: 22 Oct 2020 Time: 1405Z Position: 5153N 00126W Location: 3.5NM NW Oxford

### PART A: SUMMARY OF INFORMATION REPORTED TO UKAB

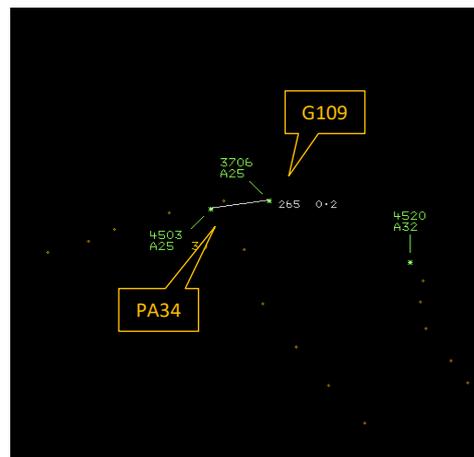
Figure 7 - 1405:19

There were no further transmissions and CPA occurred at 1405:15 with the aircraft separated by less than 100ft and 0.1NM (Figure 6). At 1408:10 the pilot of the PA34 called the Oxford controller advising that they wished to file an Airprox against the Grob 109.
