## AIRPROX REPORT No 2020154

Date: 26 Oct 2020 Time: 1551Z Position: 5239N 00032E Location: RAF Marham

### PART A: SUMMARY OF INFORMATION REPORTED TO UKAB

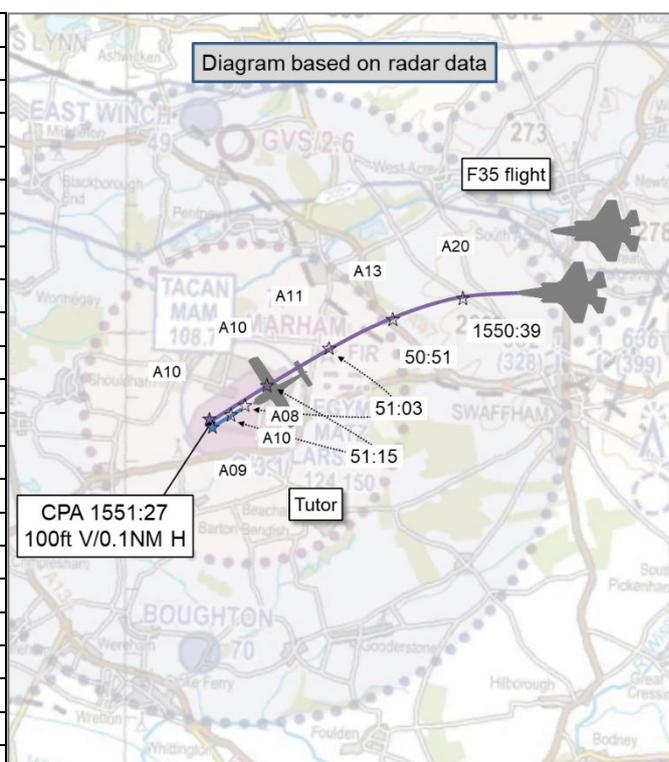
Recorded	Aircraft 1	Aircraft 2
Aircraft	Tutor	F35 x 2
Operator	HQ Air (Trg)	Foreign Mil
Airspace	Marham ATZ	Marham ATZ
Class	G	G
Rules	VFR	VFR
Service	Traffic	None <sup>1</sup>
Provider	Marham Approach	(Marham Tower)
Altitude/FL	FL014	FL015
Transponder	A, C, S	A, C, S
<b>Reported</b>		
Colours	White, blue	Grey
Lighting	Nav, landing, HISL	NK
Conditions	VMC	VMC
Visibility	40km	>10km
Altitude/FL	500ft	1000ft
Altimeter	QFE (992hPa)	Rad Alt
Heading	240°	236°
Speed	80kt	350kt
ACAS/TAS	TAS	NK
Alert	TA	NK
<b>Separation</b>		
Reported	300ft V/0m H	700ft V/100ft H
Recorded	100ft V/0.1NM H

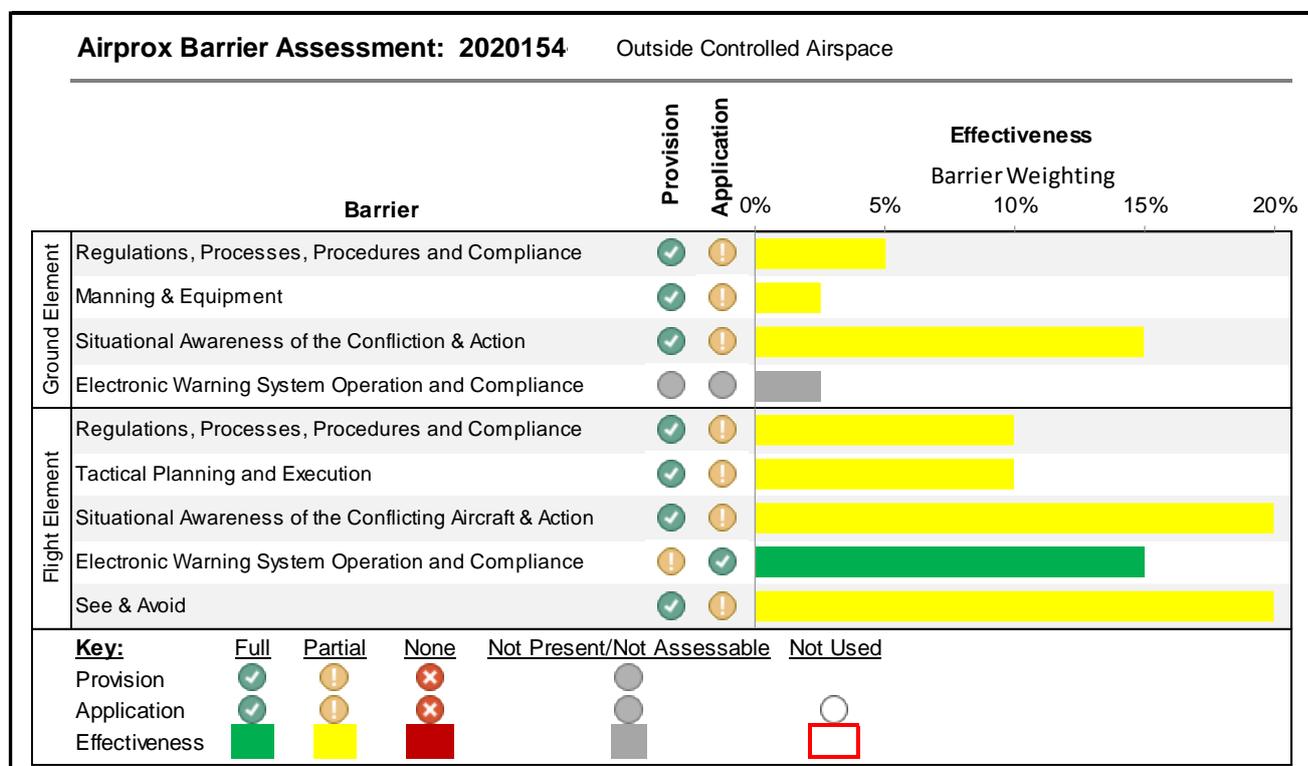
**Situational Awareness of the Conflicting Aircraft and Action** were assessed as **partially effective** because the F35 flight did not appear to assimilate the Tutor's converging flight path or take action to avoid the Tutor by a greater margin but the Tutor pilot's TAS warning enabled timely visual acquisition of the F35 flight and avoiding action.

**See and Avoid** were assessed as **partially effective** because although all parties saw the other aircraft the Tutor was avoided by an insufficient margin and could not increase separation further in the time available.
