## AIRPROX REPORT No 2020157

Date: 02 Nov 2020 Time: 1810Z Position: 5804N 0606W Location: 11NM SE of Stornoway

### PART A: SUMMARY OF INFORMATION REPORTED TO UKAB

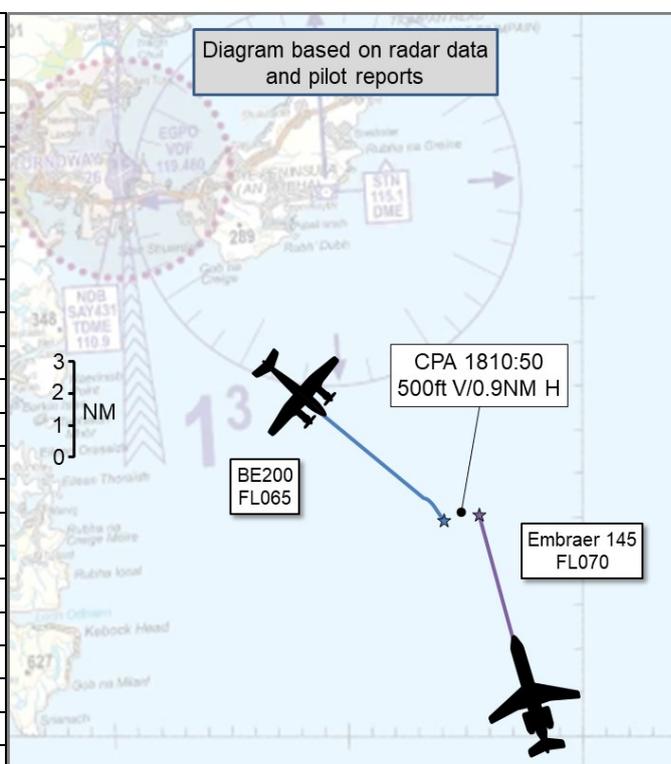
Recorded	Aircraft 1	Aircraft 2
Aircraft	BE200	Embraer 145
Operator	Civ Comm	CAT
Airspace	Scottish FIR	Scottish FIR
Class	G	G
Rules	IFR	IFR
Service	Procedural	Procedural
Provider	Stornoway	Stornoway
Altitude/FL	FL065	FL070
Transponder	A, C, S	A, C, S
<b>Reported</b>		
Colours	Not reported	White, Black
Lighting	Not reported	Strobe, Nav
Conditions	VMC	VMC
Visibility	Not reported	10KM
Altitude/FL	6000ft	FL070
Altimeter	QNH (995hPa)	QNH (1013hPa)
Heading	In the turn	343°
Speed	Not reported	220kt
ACAS/TAS	TCAS I	TCAS II
Alert	TA	RA
<b>Separation</b>		
Reported	500ft V/2NM H	500ft V/Not reported
Recorded	500ft V/0.9NM H
