**AIRPROX REPORT No 2020158**

Date: 03 Nov 2020 Time: 2017Z Position: 5100N 00238W Location: Yeovilton

**PART A: SUMMARY OF INFORMATION REPORTED TO UKAB**

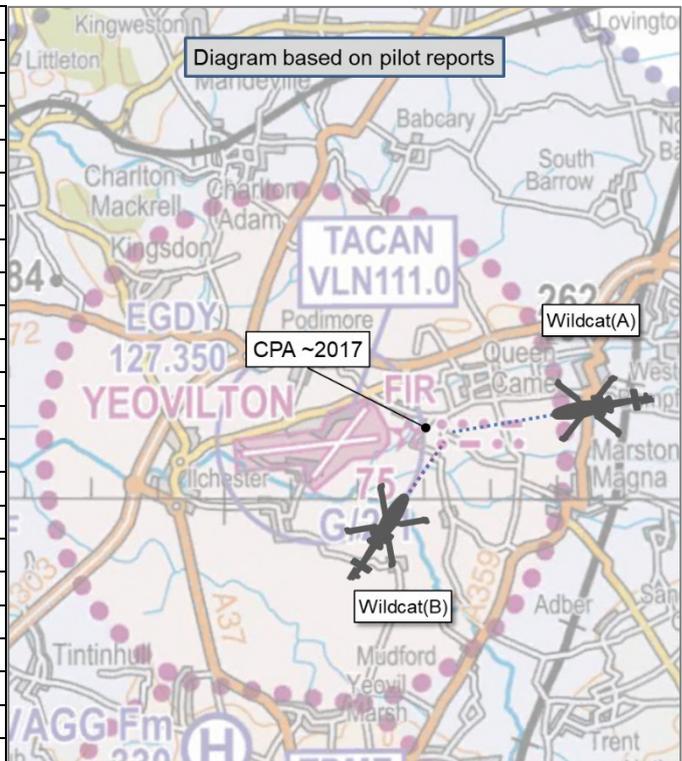
**THE WILDCAT(B) PILOT** reports that they called downwind RW22 Left at 1000ft QFE (non-NVD) and were informed of the ILS traffic and were visual. Wildcat(A) appeared to have a flight path that would place it below and behind them. As Wildcat(A) continued it 'bloomed' rapidly and the pilot could make out the navigation lights which indicated that it was closer than they had expected it to be. They instructed the student to start a climb to increase the separation and believed they reached 1200ft QFE as Wildcat(A) passed behind. They did not consider the proximity to constitute an Airprox, but it could have if they had not initiated a climb to increase separation. This was discussed in the debrief as they,

(Wildcat(B)) had called 'visual' and therefore assumed primary responsibility for deconfliction, and that distance estimation by night was difficult. Clearly [Wildcat(A) C/S] was not expecting circuit traffic and was operating on a different radio channel so was not aware that they were visual and deconflicting. The pilot noted that they held Wildcat(A) on TAS throughout. The TAS alert was generated as Wildcat(A) closed to 1NM from them. As they were visual they acknowledged the TAS alert and maintained the circuit pattern. They estimated that the closest proximity of the two aircraft was 400ft vertically and 2-300m horizontally, although as Wildcat(A) passed astern and below them, they were not visual with it as it did so. Had they not climbed their aircraft, the pilot believed that the vertical separation would have been approximately 200ft. They held Wildcat(A) visual from the ATC call and it did not hold a constant bearing (collision threat) from their aircraft; it steadily moved right and down across their field of vision, therefore they considered the risk of collision to be low.
