AIRPROX REPORT No 2021009

Date: 21 Feb 2021 Time: 1138Z Position: 5632N 00313W Location: Coupar Angus

PART A: SUMMARY OF INFORMATION REPORTED TO UKAB

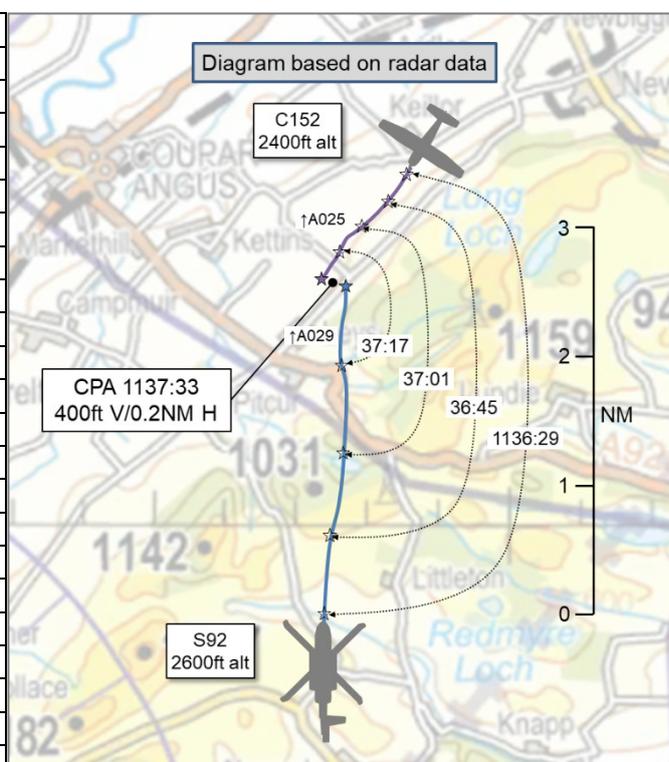
Recorded	Aircraft 1	Aircraft 2
Aircraft	S92	C152
Operator	Civ Comm	Civ FW
Airspace	Scottish FIR	Scottish FIR
Class	G	G
Rules	VFR	VFR
Service	Basic ¹	AGCS
Provider	Dundee Approach	Perth Radio
Altitude/FL	2900ft	2500ft
Transponder	A, C, S	A, C, S
Reported		
Colours	Company livery	White/silver/red
Lighting	NR	NR
Conditions	VMC	VMC
Visibility	30km	>10km
Altitude/FL	2000ft	2700ft
Altimeter	QNH (1003hPa)	NK
Heading	360°	260°
Speed	100kt	95kt
ACAS/TAS	TCAS I	Not fitted
Alert	TA	N/A
Separation		
Reported	500ft V/0.5NM H	Not Seen
Recorded	400ft V/0.2NM H
