**AIRPROX REPORT No 2021020**

Date: 30 Mar 2021 Time: 1114Z Position: 5144N 00023E Location: 3NM W of Chelmsford

**PART A: SUMMARY OF INFORMATION REPORTED TO UKAB**

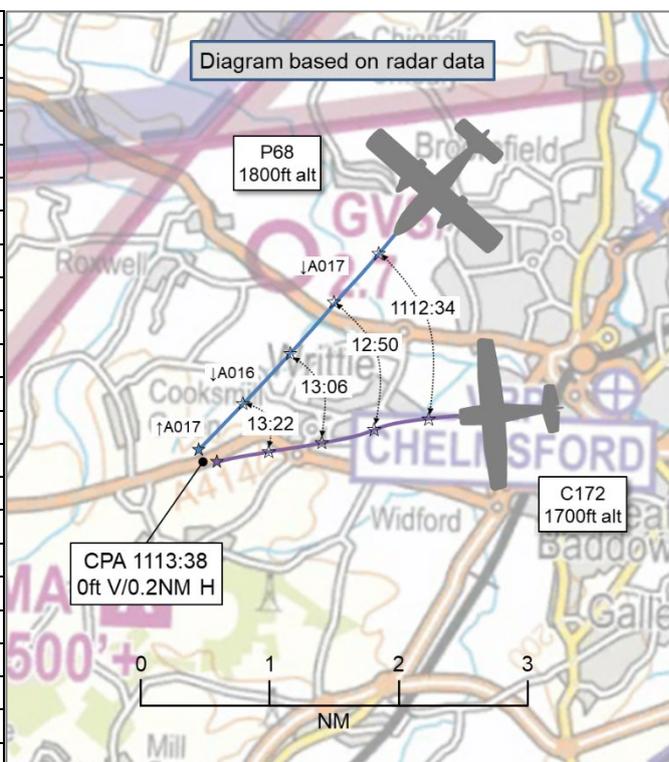
Recorded	Aircraft 1	Aircraft 2
Aircraft	P68	C172
Operator	Civ Comm	Civ FW
Airspace	London FIR	London FIR
Class	G	G
Rules	VFR	VFR
Service	Basic	Listening Out
Provider	Essex Radar	Southend Radar
Altitude/FL	A017	A017
Transponder	A, C, S	A, C, S
<b>Reported</b>		
Colours	White, blue	White, blue
Lighting	Strobes, nav lights	Anti-colls, strobes
Conditions	VMC	VMC
Visibility	'Hazy but good'	>10km
Altitude/FL	1700ft	1800-2000ft
Altimeter	QNH	QNH
Heading	'South-west'	'West'
Speed	125kt	95kt
ACAS/TAS	Not fitted	Not fitted
<b>Separation</b>		
Reported	0ft V/100m H	200ft V/>400m H
Recorded	0ft V/0.2NM H

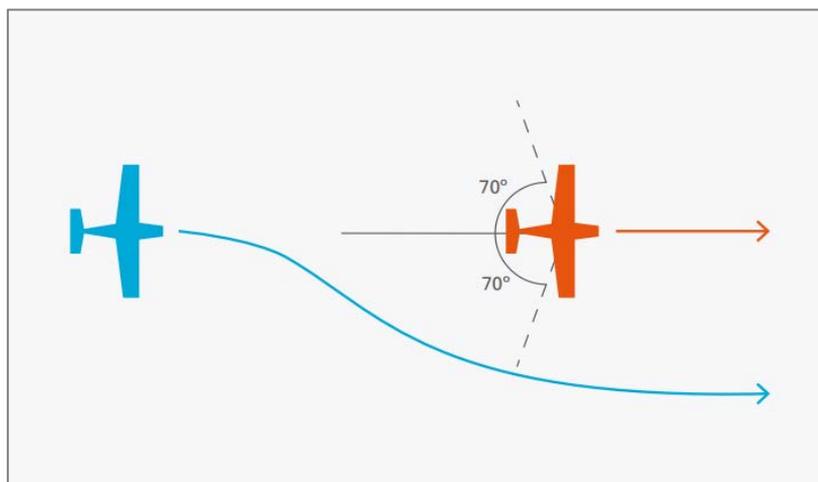
Figure 3<sup>4</sup>

additional vertical separation, particularly since the P68 pilot had had no way of knowing if the C172 pilot had been aware that the P68 was there. Therefore, the Board considered that the P68 pilot not adjusting their altitude on sighting the C172 had been contributory to the Airprox (**CF2**).
