AIRPROX REPORT No 2021028

Date: 19 Apr 2021 Time: 1032Z Position: 5127N 00120W Location: Chieveley

PART A: SUMMARY OF INFORMATION REPORTED TO UKAB

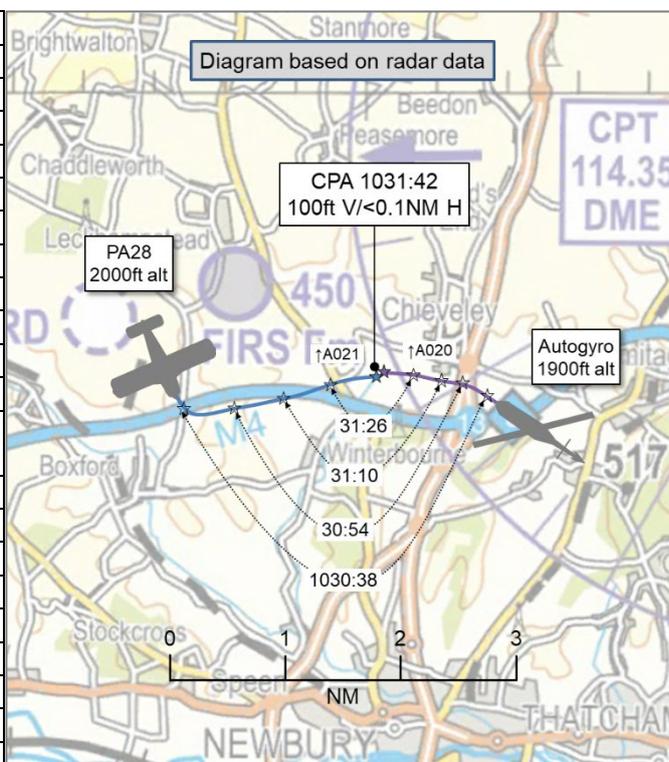
THE PA28 PILOT reports being on a biennial training flight. They had previously been general handling to the north/northwest of Newbury. Shortly after turning back onto an easterly heading, the handling pilot announced that they were not hearing the radio clearly. They looked down to adjust their headset volume and the instructor looked in to adjust comms volume on the Garmin GNS430.¹ The crew believes that they could not have been looking inside the cockpit for more than 5-10sec when a yellow autogyro was spotted very late in their 11 o'clock at a range of 15-30m, on what appeared to be an opposite track. Avoiding action was taken to the right and, although extremely close, they do not believe the aircraft would have collided. Prior to the distraction, both pilots had been maintaining a good lookout; They are surprised that they did not see the aircraft prior to the distraction. The Airprox was reported to Farnborough LARS West from whom they were in receipt of a Basic Service.

THE AUTOGYRO PILOT reports that they were on a local VFR flight. On leaving the circuit at [a local airfield], they remained on [the airfield]'s air/ground frequency and continued north towards Newbury, turning west at junction 13 of the M4 motorway. They were flying approximately 1NM north of the M4, on a heading of 270° and keeping the M4 line-feature on their left. Levelling out after the turn, they conducted a lookout scan then they briefly checked their instruments and engine temperatures and pressures. On looking up from the instruments, they saw an aircraft approaching fast in their 11 o'clock position at a range of approximately 300m, co-altitude and on a reciprocal heading. They immediately initiated a steep descending turn to starboard. They did not notice the other aircraft make any change in course.
