AIRPROX REPORT No 2021043

Date: 20 Apr 2021 Time: 1056Z Position: 5216N 00111W Location: Daventry

PART A: SUMMARY OF INFORMATION REPORTED TO UKAB

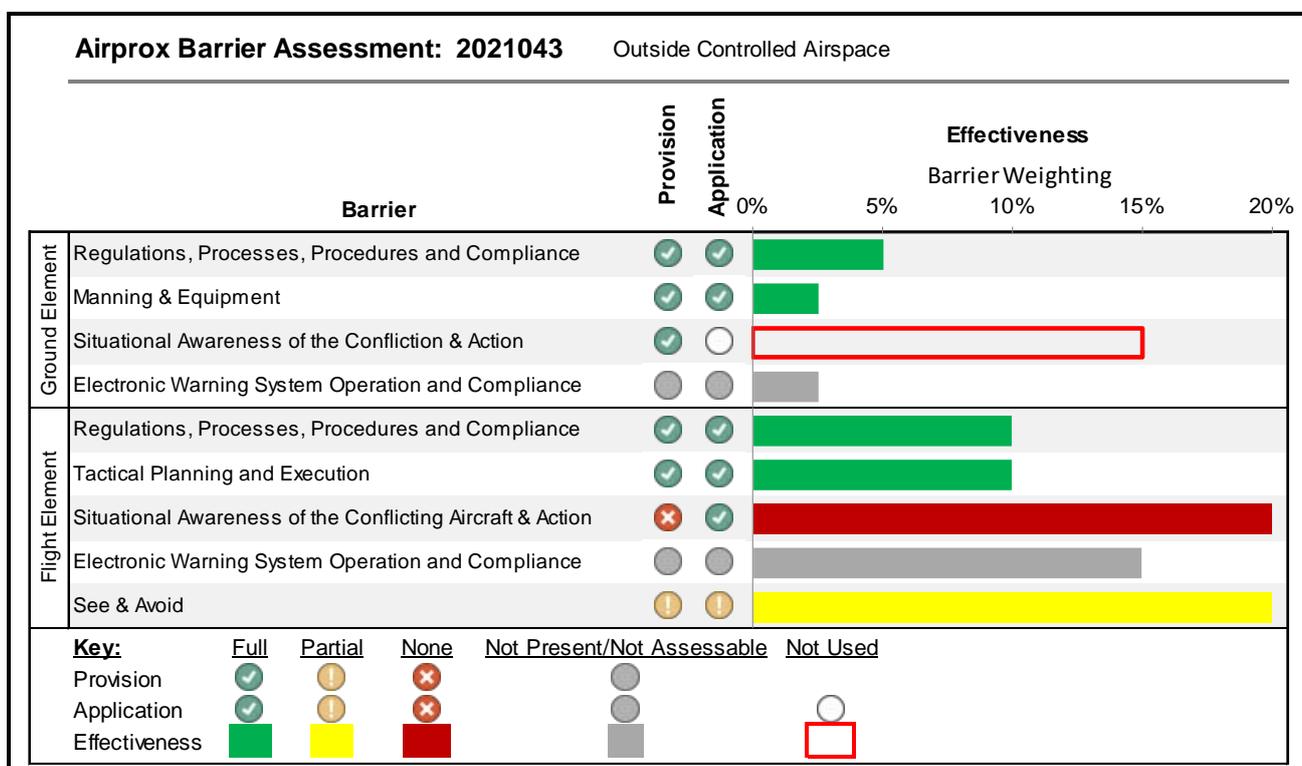
Situational Awareness of the Conflicting Aircraft and Action were assessed as **ineffective** because neither pilot had any situational awareness of the presence of the other aircraft.

See and Avoid were assessed as **partially effective** because the pilots of both aircraft only saw the other aircraft at a late stage and each of them had to initiate emergency avoiding action.
