AIRPROX REPORT No 2021045

Date: 27 Apr 2021 Time: 1512Z Position: 5129N 00045W Location: White Waltham circuit

PART A: SUMMARY OF INFORMATION REPORTED TO UKAB

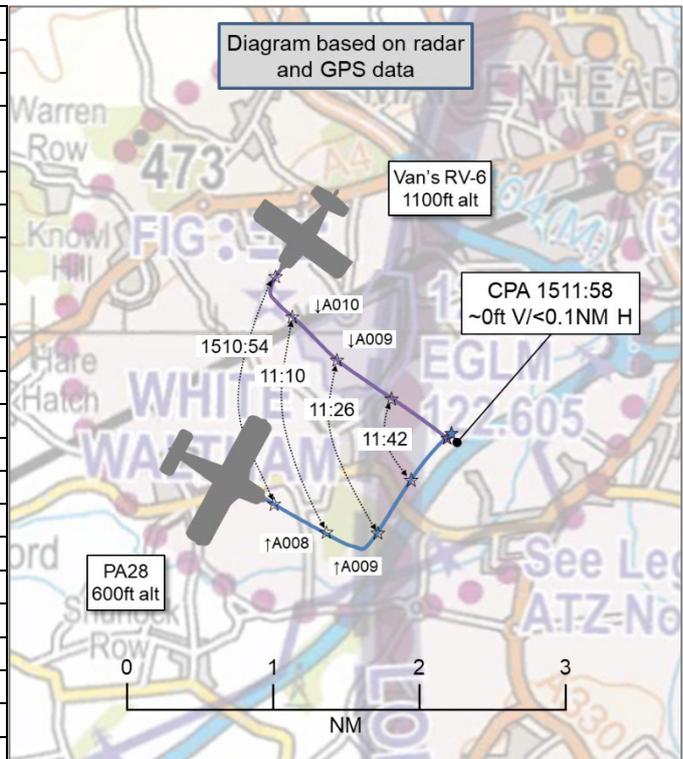
Recorded	Aircraft 1	Aircraft 2
Aircraft	PA28	Van's RV-6
Operator	Civ FW	Civ FW
Airspace	White Waltham ATZ	White Waltham ATZ
Class	G	G
Rules	VFR	VFR
Service	AGCS	AGCS
Provider	Waltham Radio	Waltham Radio
Altitude/FL	A009	900ft ¹
Transponder	A, C, S	A
Reported		
Colours	White/grey/red	Cream/blue
Lighting	Nav lights	Nil
Conditions	VMC	VMC
Visibility	>10km	15km
Altitude/FL	800ft	900ft
Altimeter	QFE	QFE (1003hPa)
Heading	030°	110°
Speed	95kt	90kt
ACAS/TAS	SkyEcho	SkyEcho 2
Alert	Information	None
Separation		
Reported	25ft V/0m H	100ft V/100m H
Recorded	~0ft V/<0.1NM H ²

² Vertical separation measured by comparing radar data for the PA28 with the GPS data of the Van's RV-6; horizontal separation measured from the NATS radar replay.

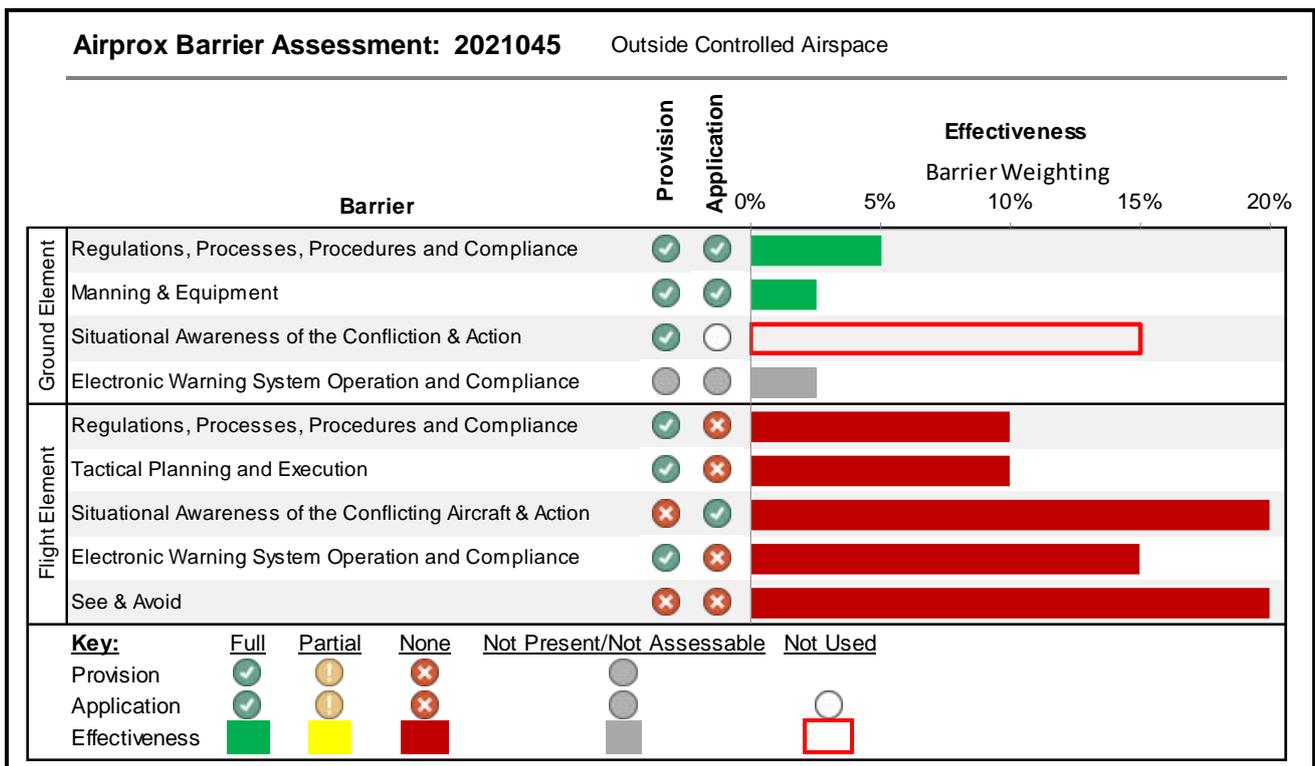
Electronic Warning System Operation and Compliance were assessed as **ineffective** because the RV-6 pilot did not receive any indication from their SkyEcho of the presence of the PA28, and the PA28 pilot received an alert from their SkyEcho but disregarded the warning as something to be expected in the visual circuit.

See and Avoid were assessed as **ineffective** because neither pilot saw the other aircraft in time to materially affect the separation between the 2 aircraft.
