AIRPROX REPORT No 2021060

Date: 27 May 2021 Time: 1151Z Position: 5104N 00102W Location: Colemore Common

PART A: SUMMARY OF INFORMATION REPORTED TO UKAB

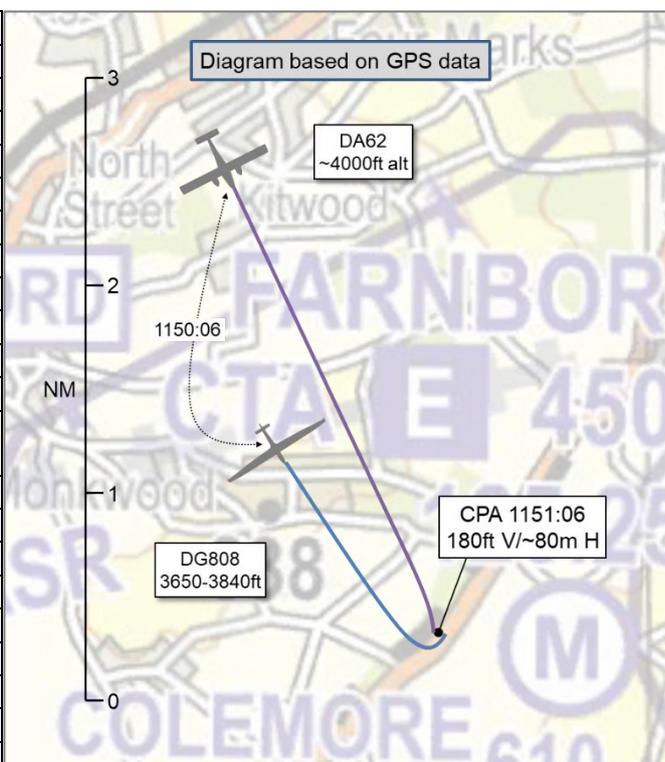
Recorded	Aircraft 1	Aircraft 2
Aircraft	DG808	DA62
Operator	Civ Gld	Civ FW
Airspace	London FIR	London FIR
Class	G	G
Rules	VFR	VFR
Service	Listening Out	Basic
Provider	Gliding frequency	Farnborough
Altitude ¹	3840ft	4020ft
Transponder	Off	A, C, S
Reported		
Colours	White	Grey
Lighting	Not fitted	Strobe, landing, taxi
Conditions	VMC	VMC
Visibility	>10km	>10km
Altitude/FL	4000ft	4000ft
Altimeter	QNH (NK hPa)	QNH (1020hPa)
Heading	~135°	150°
Speed	65kt	153kt
ACAS/TAS	FLARM	TAS
Alert	None	None
Separation		
Reported	0ft V/100ft H	NK V/NK H
Recorded	180ft V/~80m H

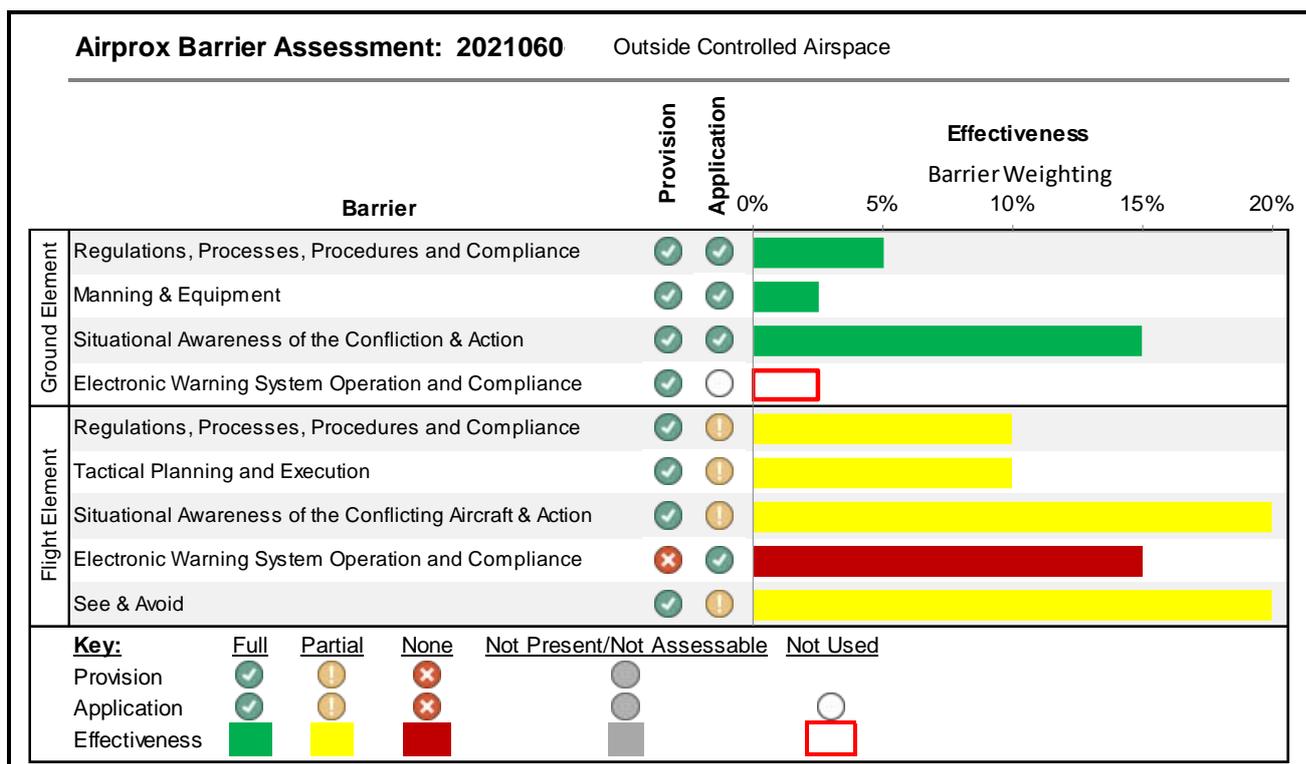
Electronic Warning System Operation and Compliance were assessed as **ineffective** because the DG808 transponder was not available to generate a potential alert in the DA62 TAS.

See and Avoid were assessed as **partially effective** because the glider pilot saw the DA62 at about CPA, an effective non-sighting, and the DA62 pilot had to react to the glider pilot's turn when at close range and hence at a late stage.
